LEAD-BASED PAINT/CERAMIC TILE INSPECTION REPORT

OLD PIONEER ADULT SCHOOL
BUILDINGS B, D AND E
1651 EAST ROWLAND AVENUE
WEST COVINA, CALIFORNIA 91791

Project Number EE 18-Z0172-0076
April 25, 2018

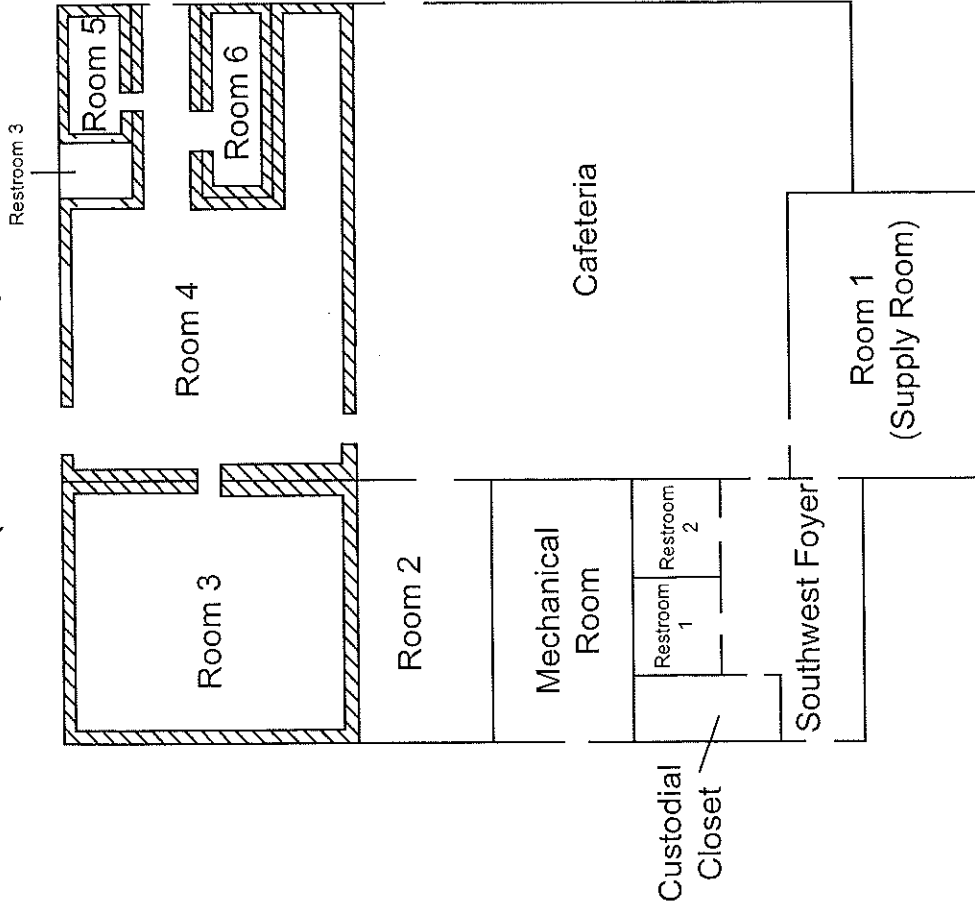
Building B (Cafeteria)

▨ - Ceramic tile Baseboard

Client: Covina-Valley USD	Project #: 18-Z0172-0076	Info: Lead Based Paint Identified

It is recommended that all renovation, remodelling, construction, or demolition actions that might potentially disturb surfaces covered with lead-based paint be performed by properly trained and qualified personnel.

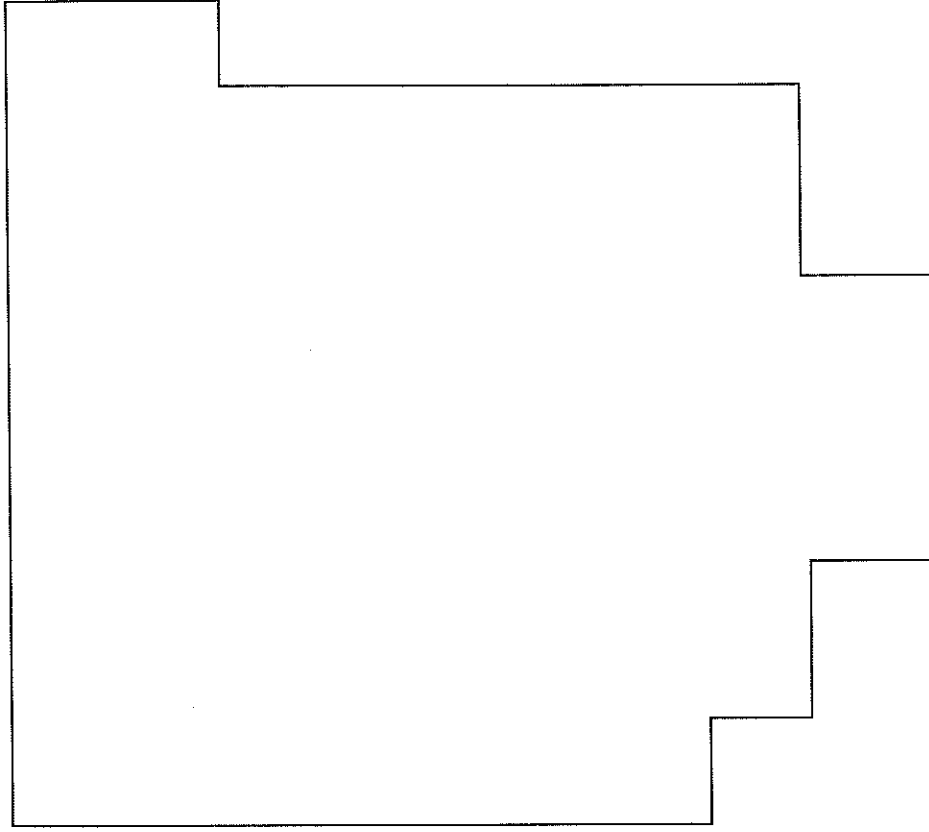
Building B
(Cafeteria)
Exterior

Info: No Lead Based Paint Identified

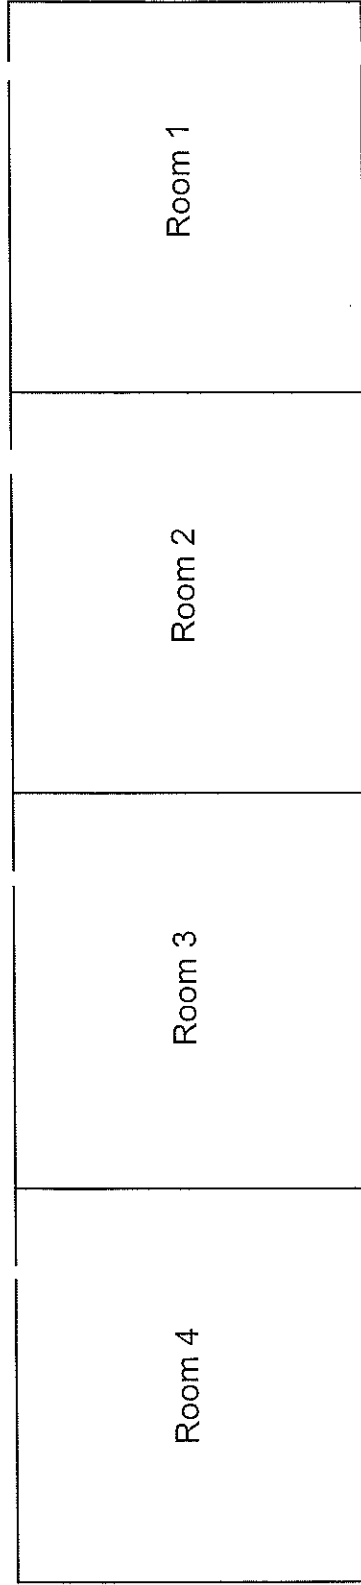
Building D (Rooms 1 through 4)

Client: Covina-Valley USD	Project #: 18-Z0172-0076	Info: No Lead Based Paint Identified

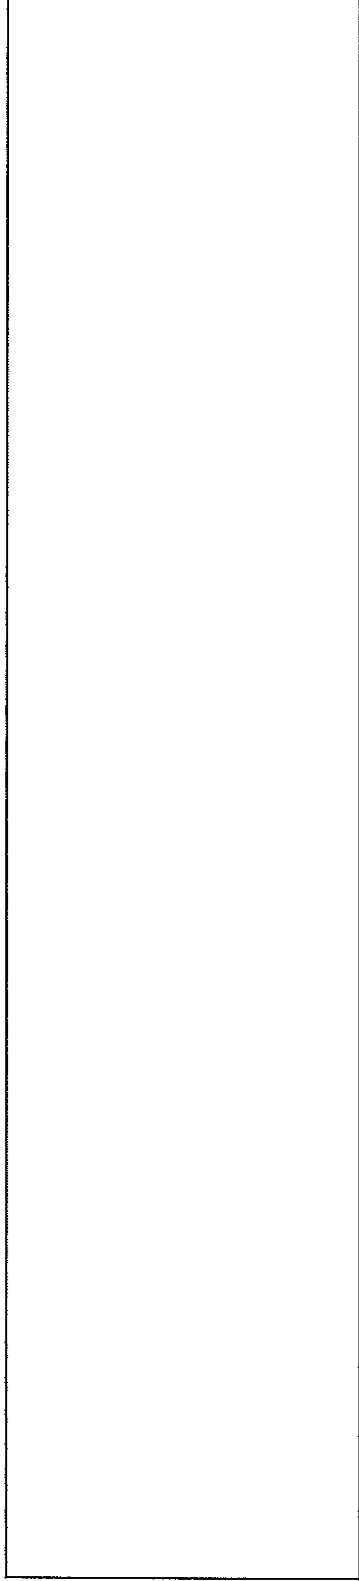
Building D
Exterior

Info: No Lead Based Paint Identified

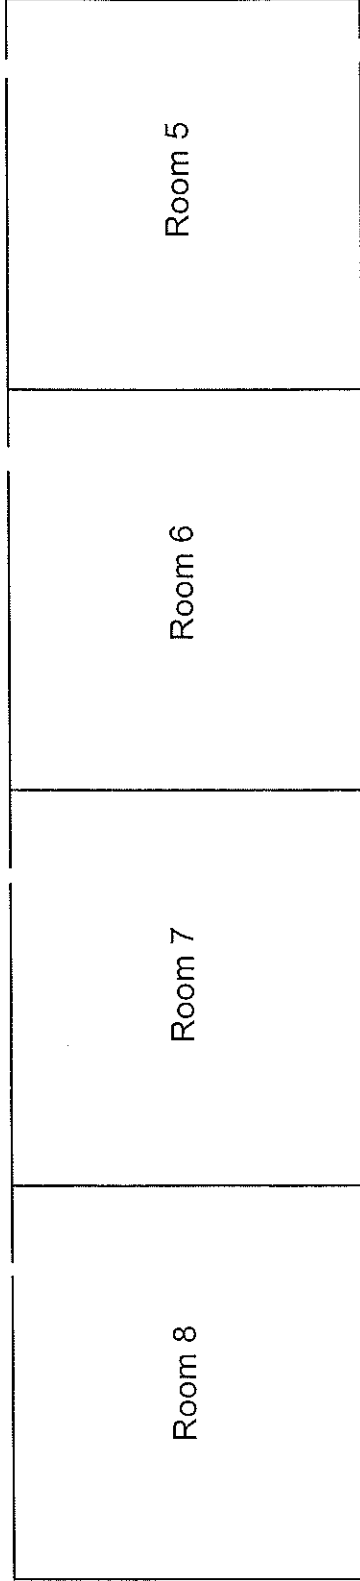
Building E (Rooms 5 through 8)

Client: Covina-Valley USD	Project #: 18-Z0172-0076	Info: No Lead Based Paint Identified

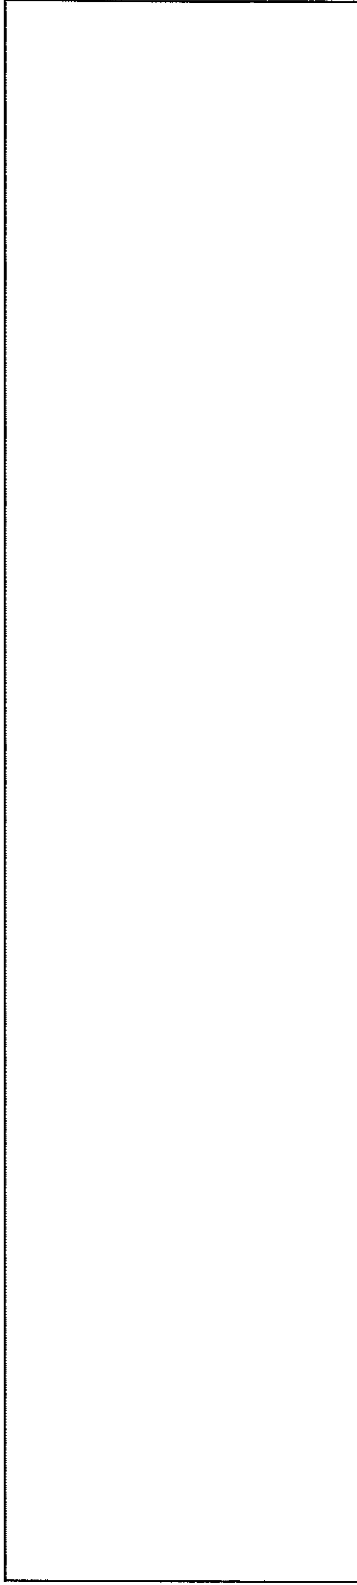
Building E Exterior

Info: No Lead Based Paint Identified
