Asbestos and Lead-Based Paint Survey Report

**Subject: ACM and LBP Survey Report
Amazon Site Code – DAX9
1211 Badillo Street, West Covina, California**

Asbestos and Lead-Based Paint Survey Report
BADILLO ENTERPRISES PROPERTY
1211 Badillo Street, West Covina, California

24 June 2020
Project No. 20-6029

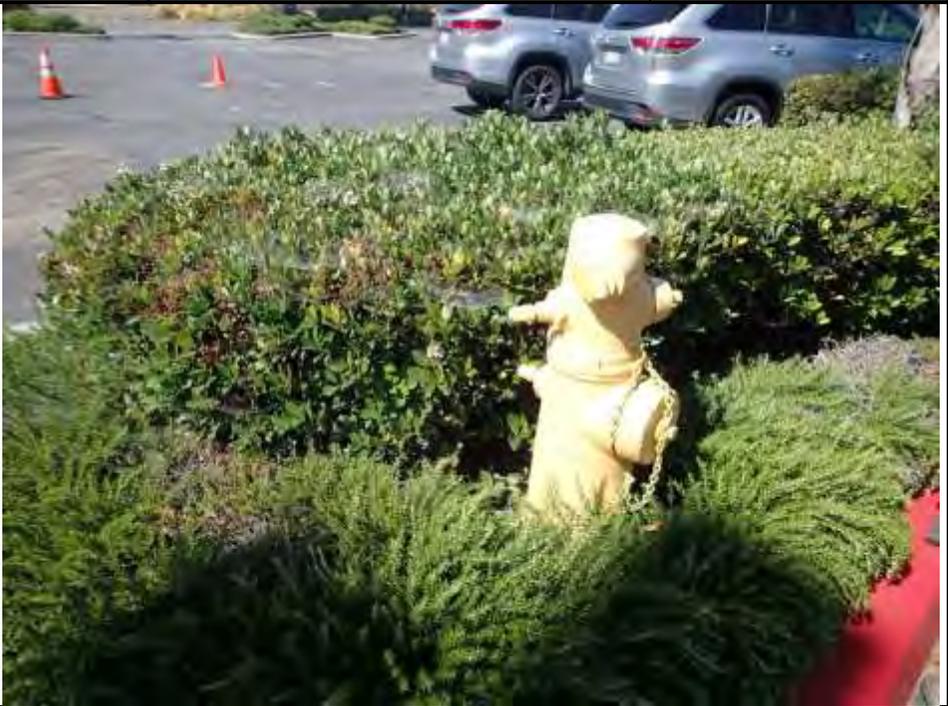
Photo No. 1

Description: LBP - Metal Fire Hydrant, Yellow - Parking Area Planters Around the Property

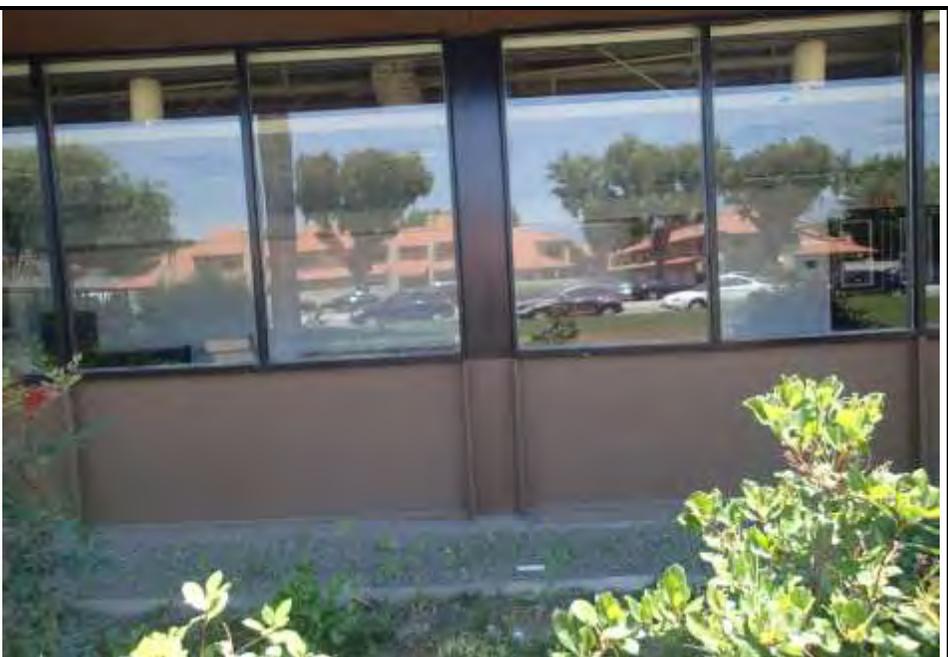
Photo No. 2

Description: LBP- Steel Building Support Columns, Black, Brown – Throughout Building

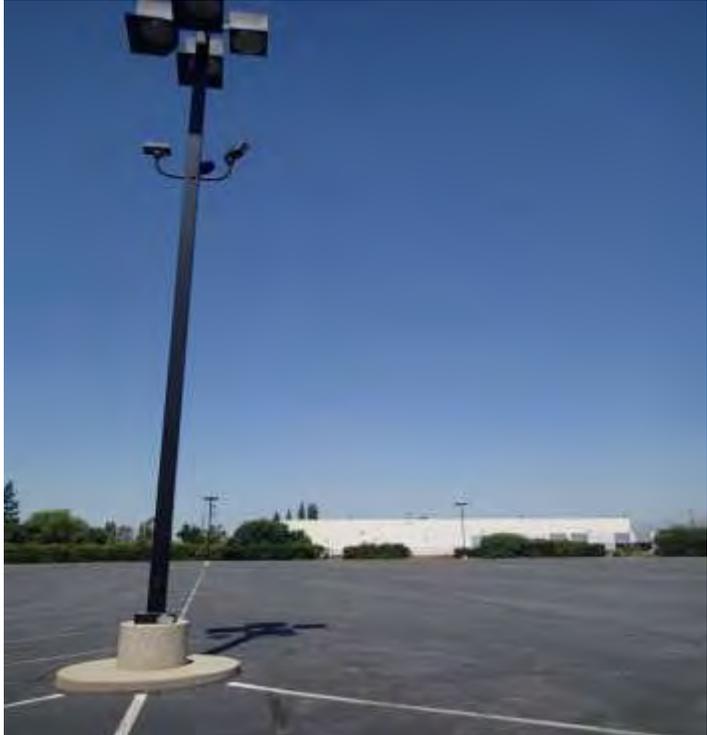
Client Name: Geosyntec Consultants	Site Location: 1211 Badillo Street West Covina, California	Project No.: 20-6029
Photo No. 5 Description: LBP - Metal Lamp Post (with 4 Lights), Black, Parking Lot East, South and West

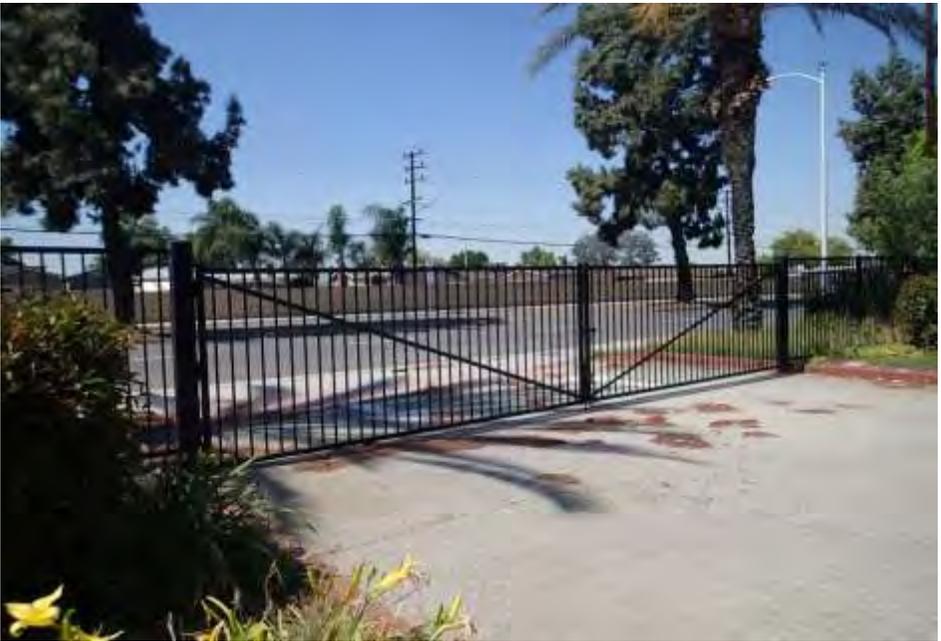
Photo No. 6 Description: LBP - Metal Gate Post (6" sides), Black - Southeast Entry

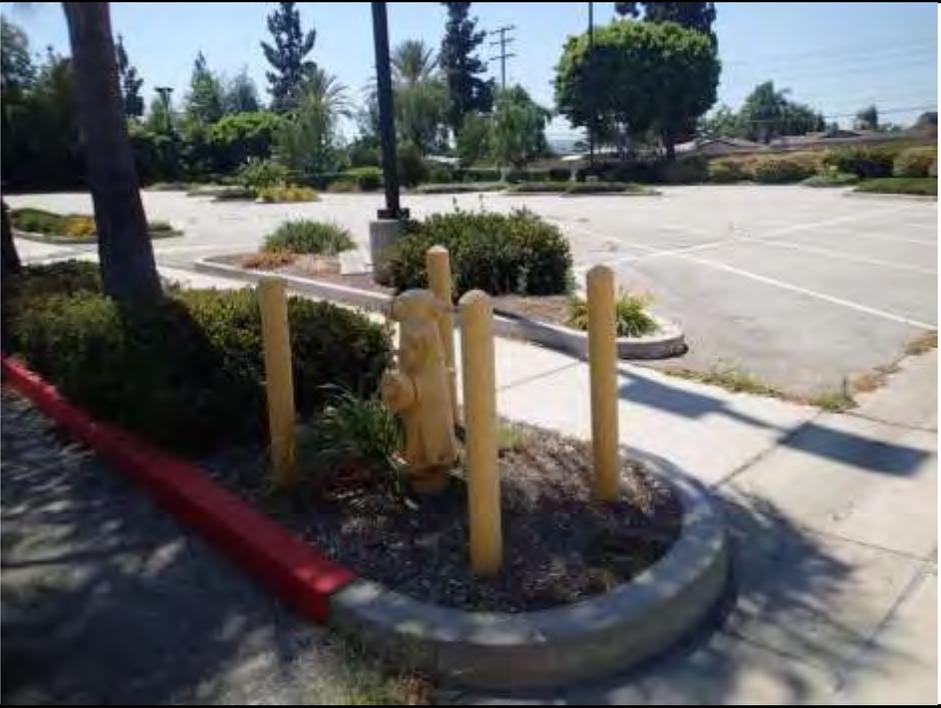
Client Name: Geosyntec Consultants	Site Location: 1211 Badillo Street West Covina, California	Project No.: 20-6029
Photo No. 7 Description: LBP - Metal Bollard, Yellow, Southeast Parking Area Planter

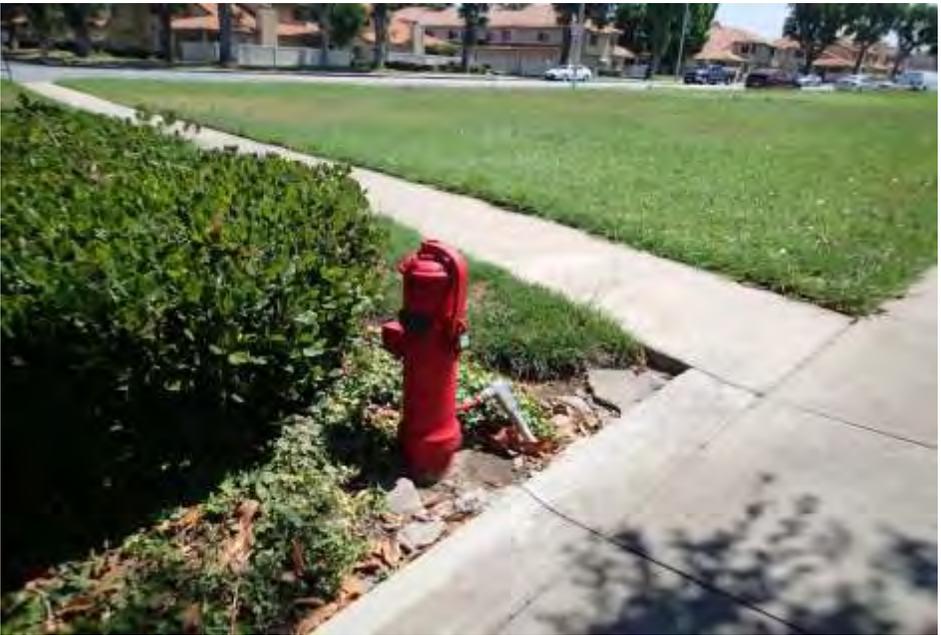
Photo No. 8 Description: LBP - Metal Fire Hydrant, Red – Planters around the Building

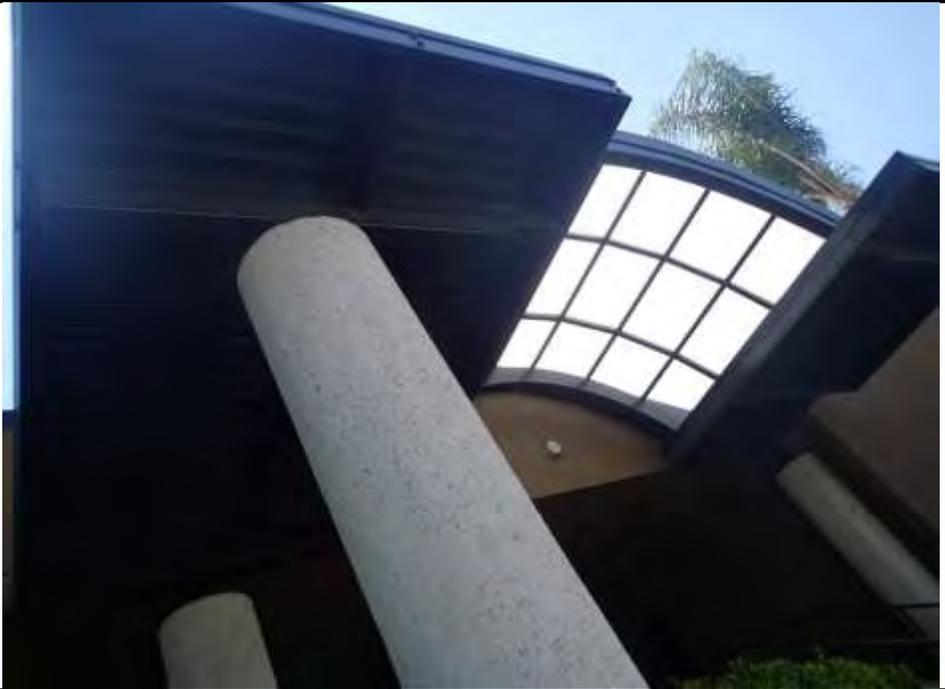
Client Name: Geosyntec Consultants	Site Location: 1211 Badillo Street West Covina, California	Project No.: 20-6029
Photo No. 9 Description: LBP - Metal Awning Frame, Black, West Side Main Entry

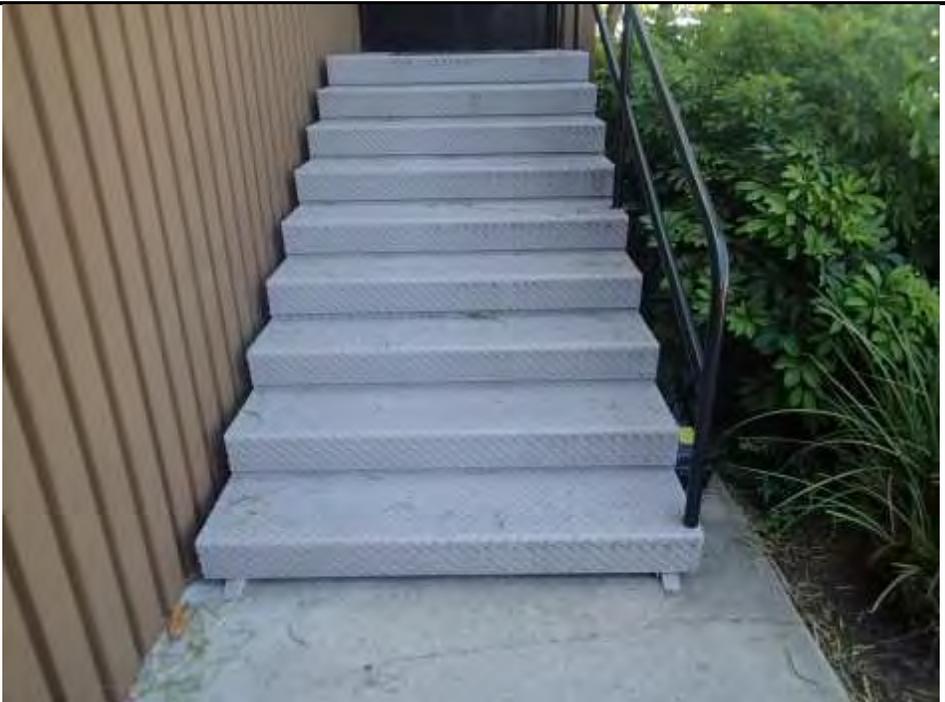
Photo No. 10 Description: LBP - Metal Stair Step and Riser, Gray, West Side Southwest Exterior Stairs

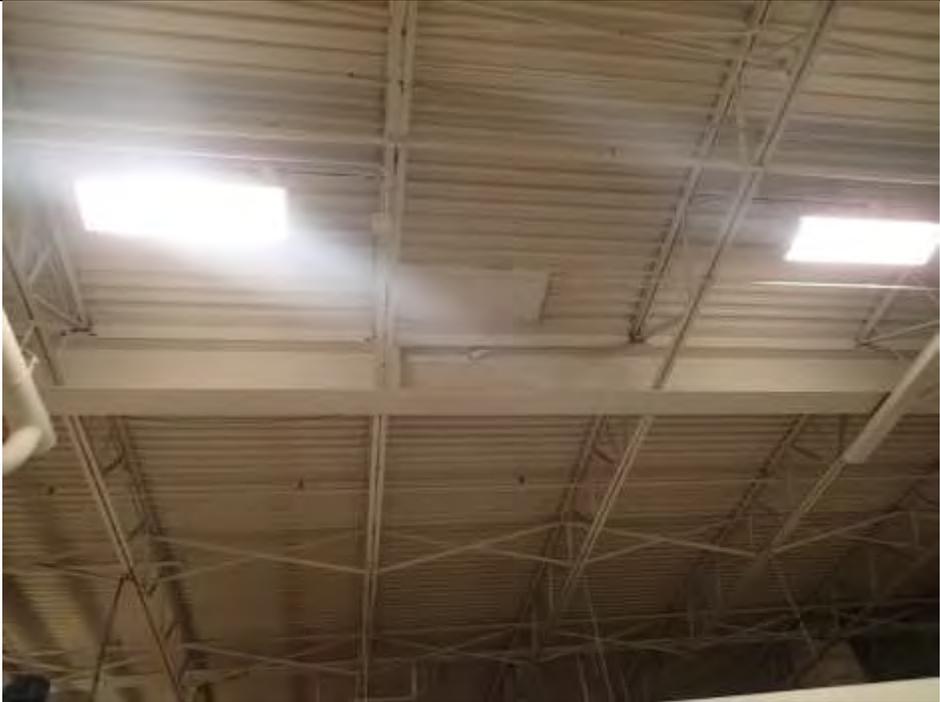
Client Name: Geosyntec Consultants	Site Location: 1211 Badillo Street West Covina, California	Project No.: 20-6029
Photo No. 11 Description: LBP - Metal Beam / Girder, Off-white, Roof and Building Framing

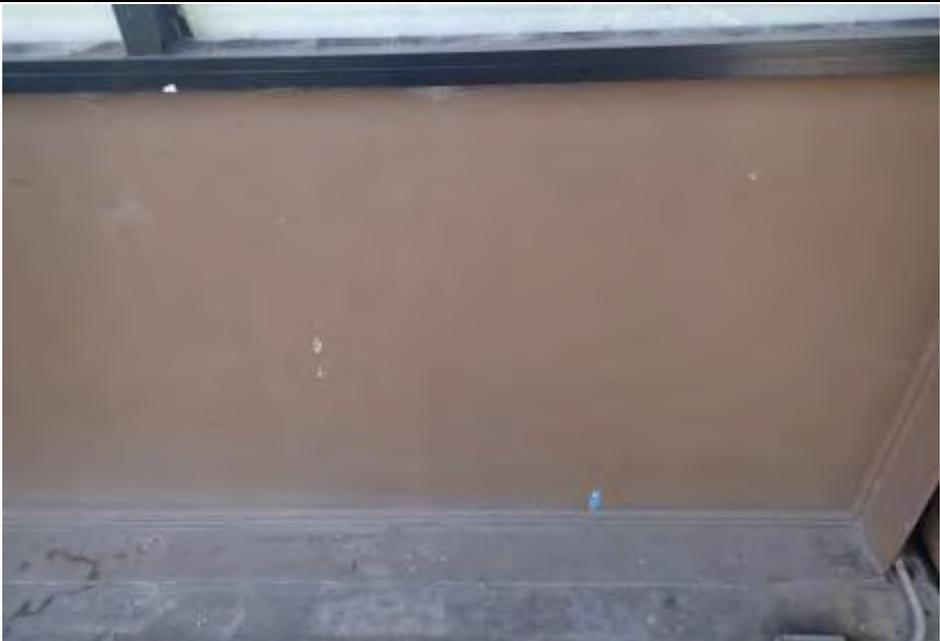
Photo No. 12 Description: LBP - Aluminum Window Transom, Brown over Blue, North Perimeter Wall

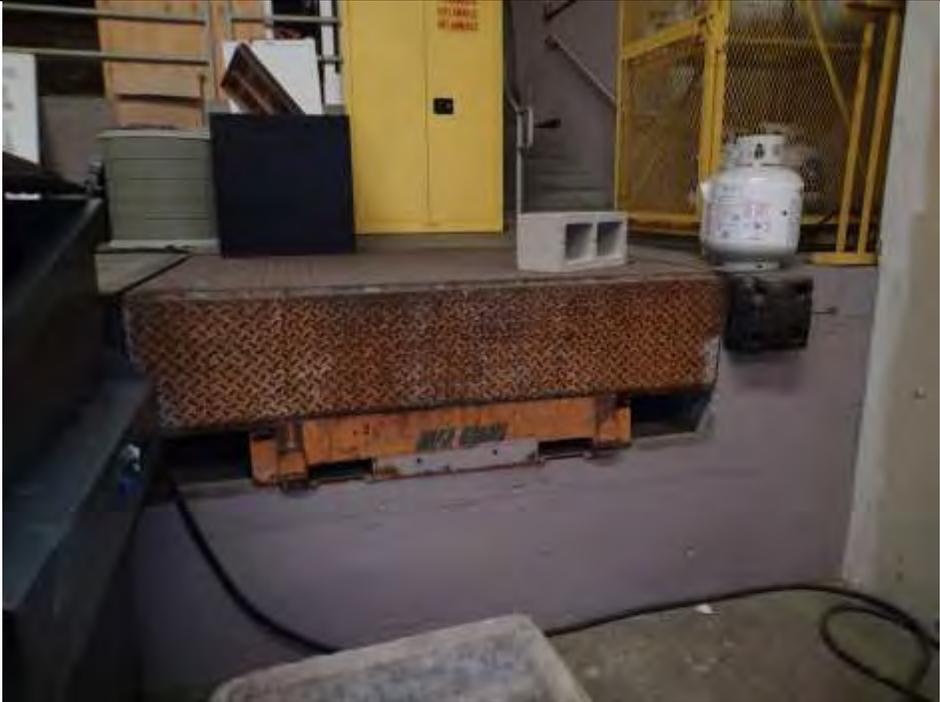
Client Name: Geosyntec Consultants	Site Location: 1211 Badillo Street West Covina, California	Project No.: 20-6029
<p>Photo No. 13</p> <p>Description: LBP - Metal Loading Stage, Orange, Loading dock Southwest</p>

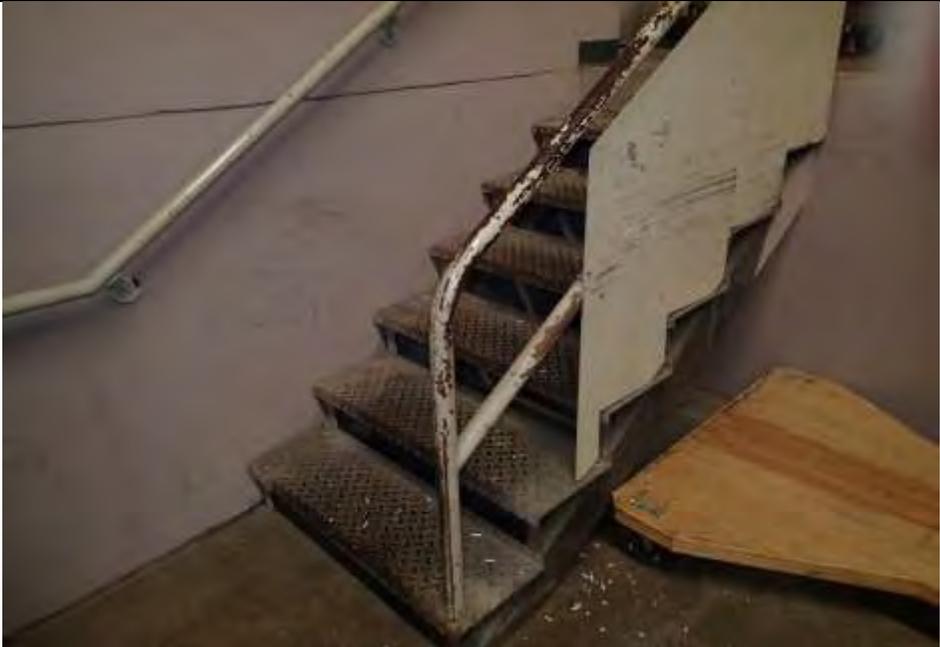
<p>Photo No. 14</p> <p>Description: LBP - Metal Stair Steps and Stringer, White Loading Area Steps</p>
