PRIMARY RECORD

*Resource Name or #: 1314 E. Puente Ave.

*P10. Survey Type: (Describe) Intensive Survey of pre-1946 homes in West Covina city boundaries

BUILDING, STRUCTURE, AND OBJECT RECORD

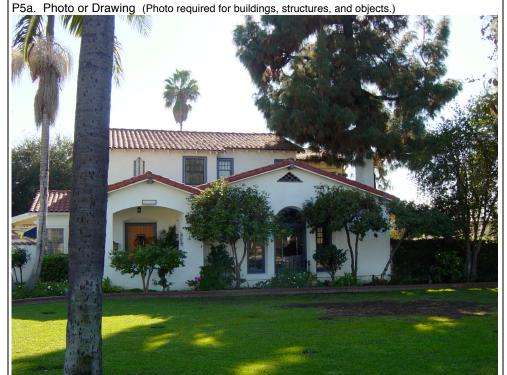
The house located at 1314 East Puente avenue is a two story Spanish Colonial Revival home built in 1926. The house has a cross gabled roof with slight overhanging eaves and exposed rafter tails. The multi-level roof is finished in regularly laid mission-style red tiles and the exterior walls are finished in stucco. There is decorative venting located at the peak of the front gable. The window fenestration is variegated with a focal balcony window on the first floor and double hung and flush windows on the second floor. There is a partial width front entry porch with arch above principal door. The house is on a large well-maintained grassy lot with mature trees and planting. There is a low brick border wall which surrounds the front garden. The house appears to be well maintained with little alteration. The house fronts north on Puente Ave. and is listed with the Los Angeles County Assessors Office as being a four bedroom, two bath home with 2,330 interior square feet and is situated on a 23,090 square foot lot.

P5b. Description of Photo: (View South, taken Nov. 22, 2005)
