# Proposed Residential Development at 1024 West Workman Avenue

## Arborist Report

**September 2020**

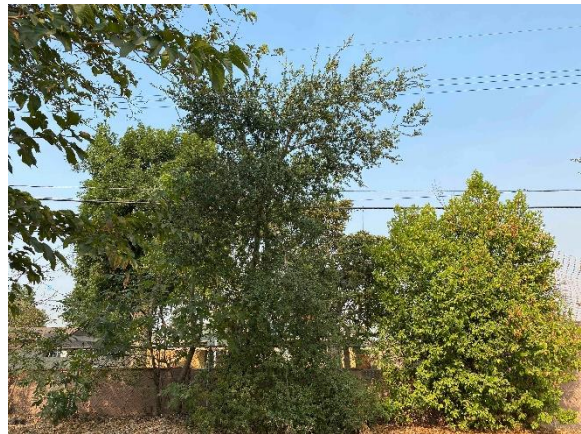
**Tree #18**

The three newly added trees (#s T18 to T20) were located along the western and southern boundaries of the site in areas identified as existing scrub in the Existing Tree Inventory Plan. Trees T18 and T19 are growing between a chain link fence and cinder block wall, and Tree T20 is growing immediately north of a wooden fence.

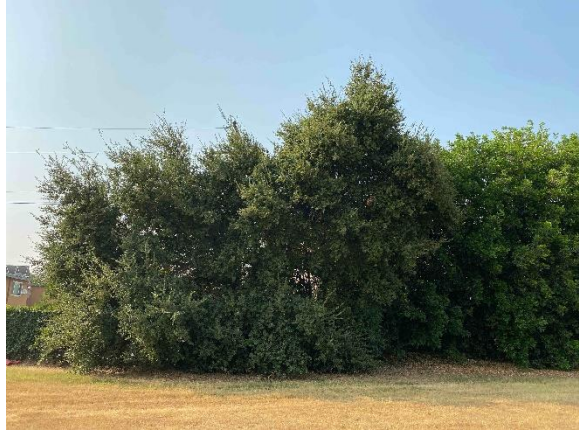
**Tree #20**

T20	coast live oak ( <i>Quercus agrifolia</i> )	13, 13, 18	45	40	S	On-site. Fair condition, large tree with new growth evident, tent caterpillars present but do not appear to be affecting tree vitality.
