Arborist Report

1616 West Cameron Avenue Project

December 2020

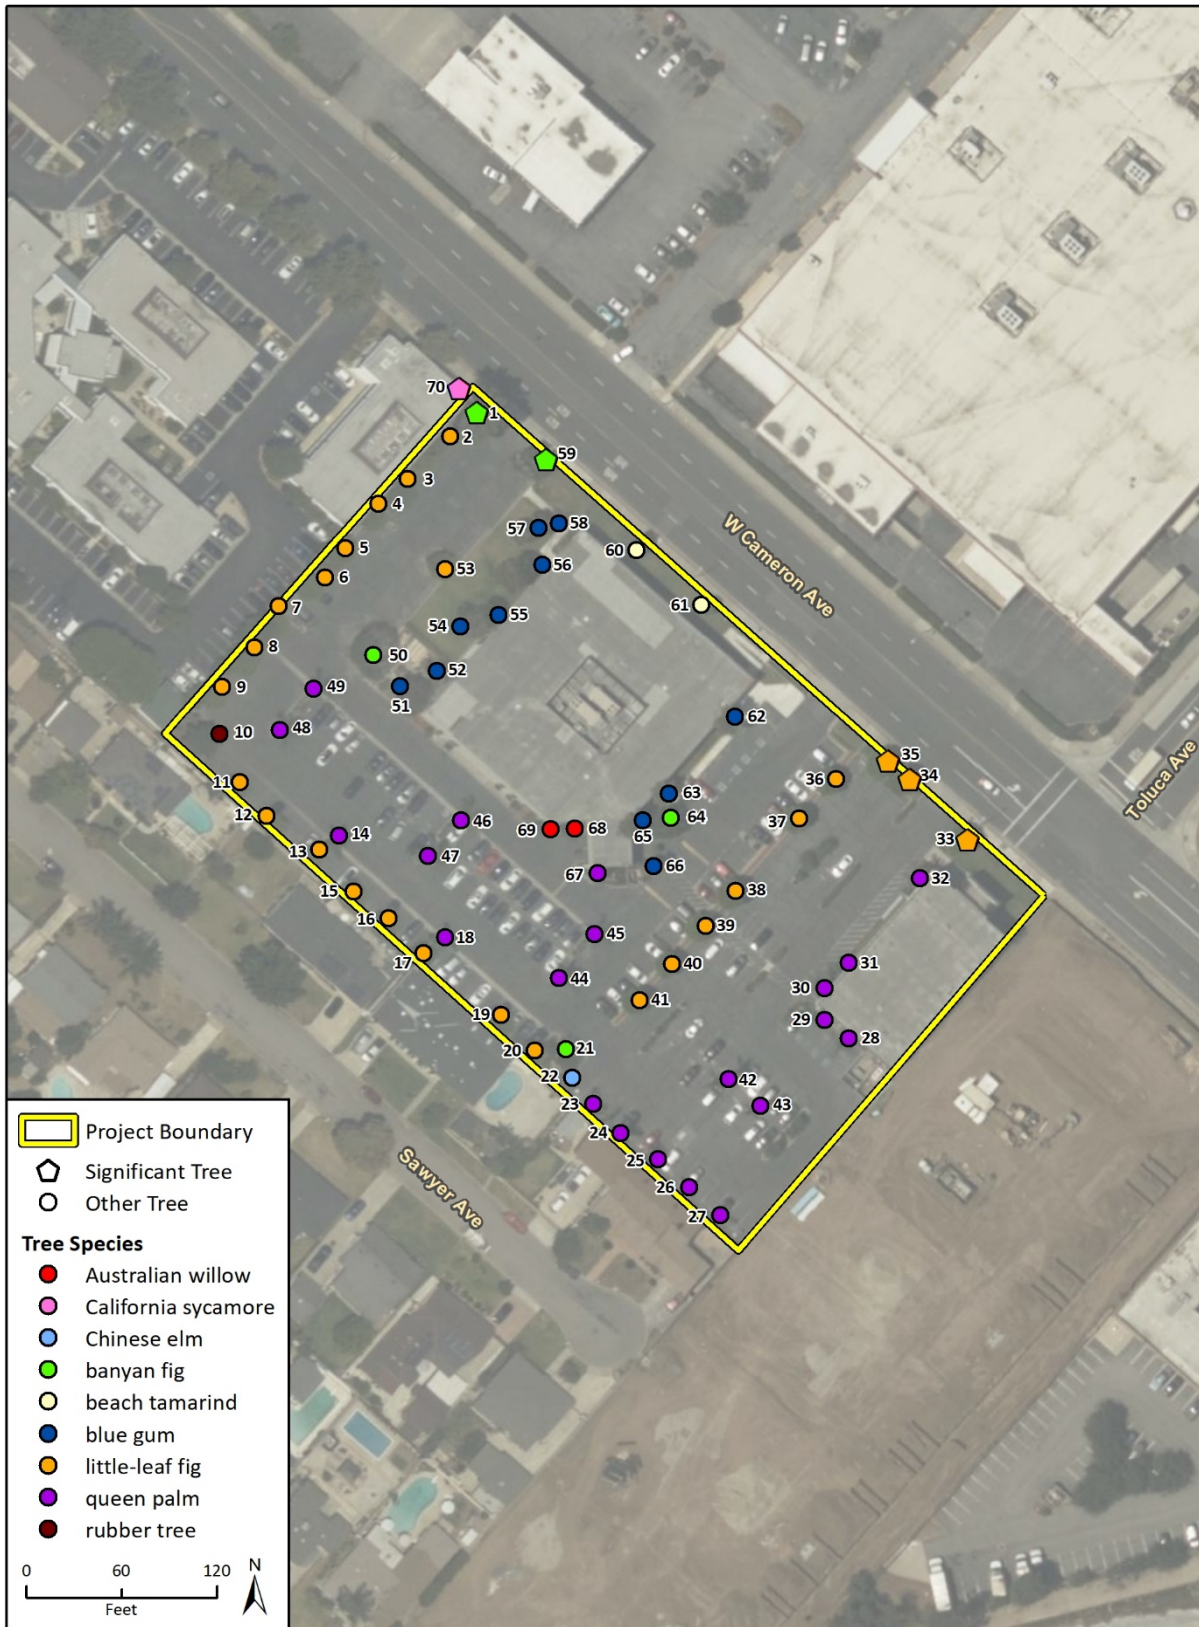
Figure 3 Trees

Seventy trees are located within or immediately adjacent to the project site that were surveyed, as depicted in Figure 3. The trees consist primarily of planted ornamental and landscape species that includes: 26 little-leaf fig (*Ficus microcarpa*), 21 queen palm (*Syagrus romanzoffiana*), 11 blue gum (*Eucalyptus globulus*), five banyan figs (*Ficus benghalensis*), two beach tamarind (*Cupaniopsis anacardioides*), two Australian willow (*Geijera parviflora*), one Chinese elm (*Ulmus parvifolia*), one rubber tree (*Ficus elastica*), and one native California sycamore (*Platanus racemosa*). Most of the surveyed trees were in good or fair condition showing only minor flaws or health issues. However, one blue gum eucalyptus was in poor condition due to excessive pruning.

Of the 70 trees, six are significant trees per the Ordinance, and 64 are non-significant trees. No heritage trees were identified. Sixty-nine trees have trunks on the project site, and one tree trunk is located on the property immediately northwest of the project site, with its crown overhanging the project site. Photographs of significant trees are provided in Appendix A; a Tree Matrix with data for all trees within the study area is provided in Appendix B.

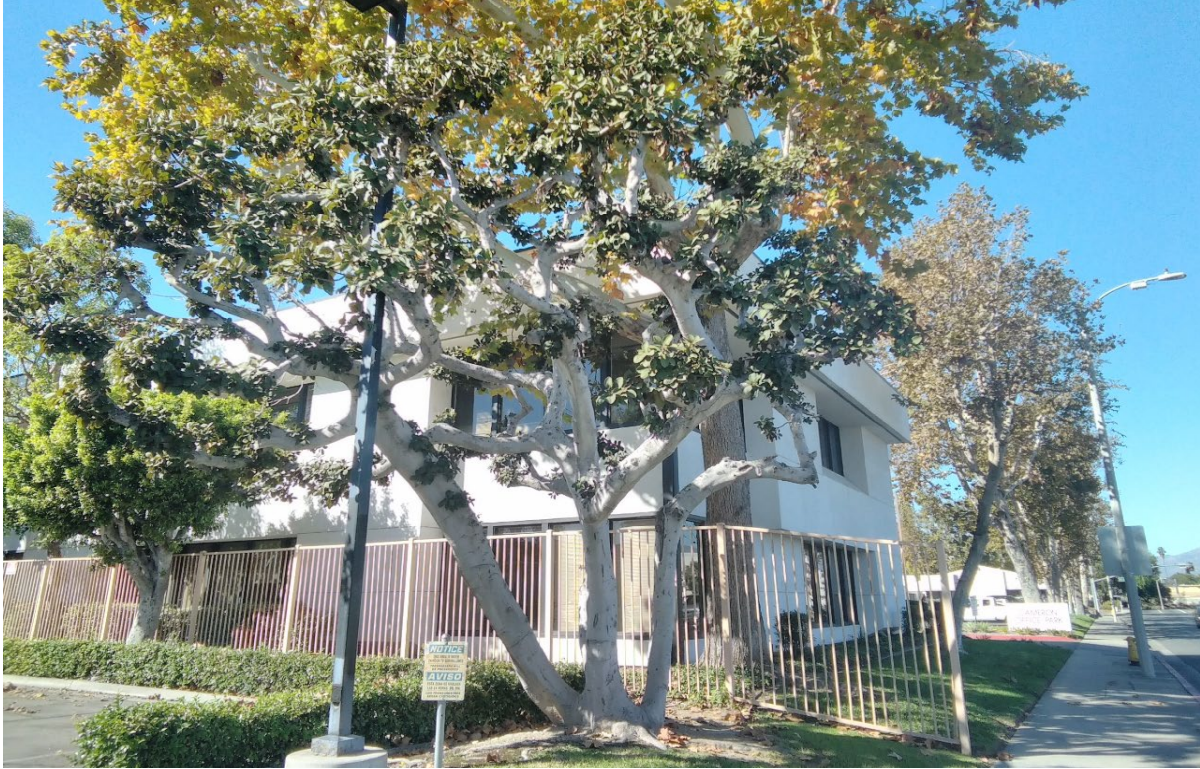
Photograph 1. Tree 1, banyan fig (*Ficus benghalensis*). City Significant Tree. Tree 70 is visible in background.

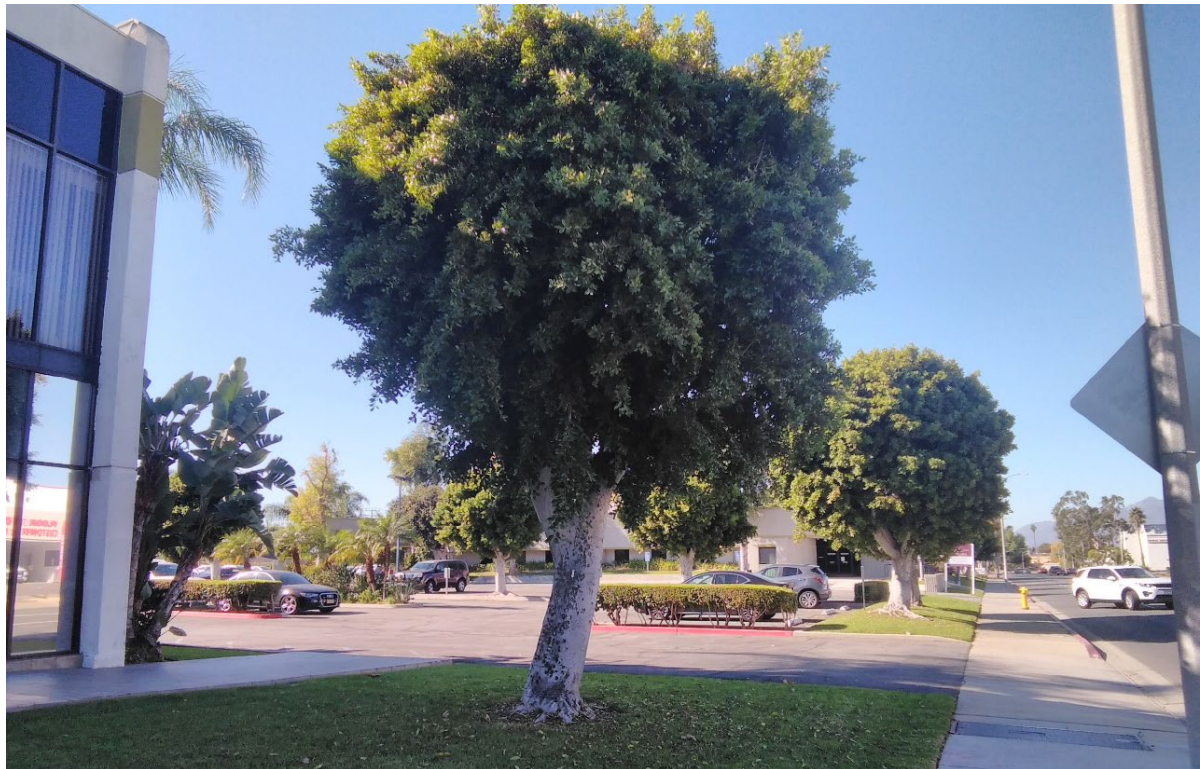
Photograph 2. Tree 33, little-leaf fig (*Ficus microcarpa*). City Significant Tree.

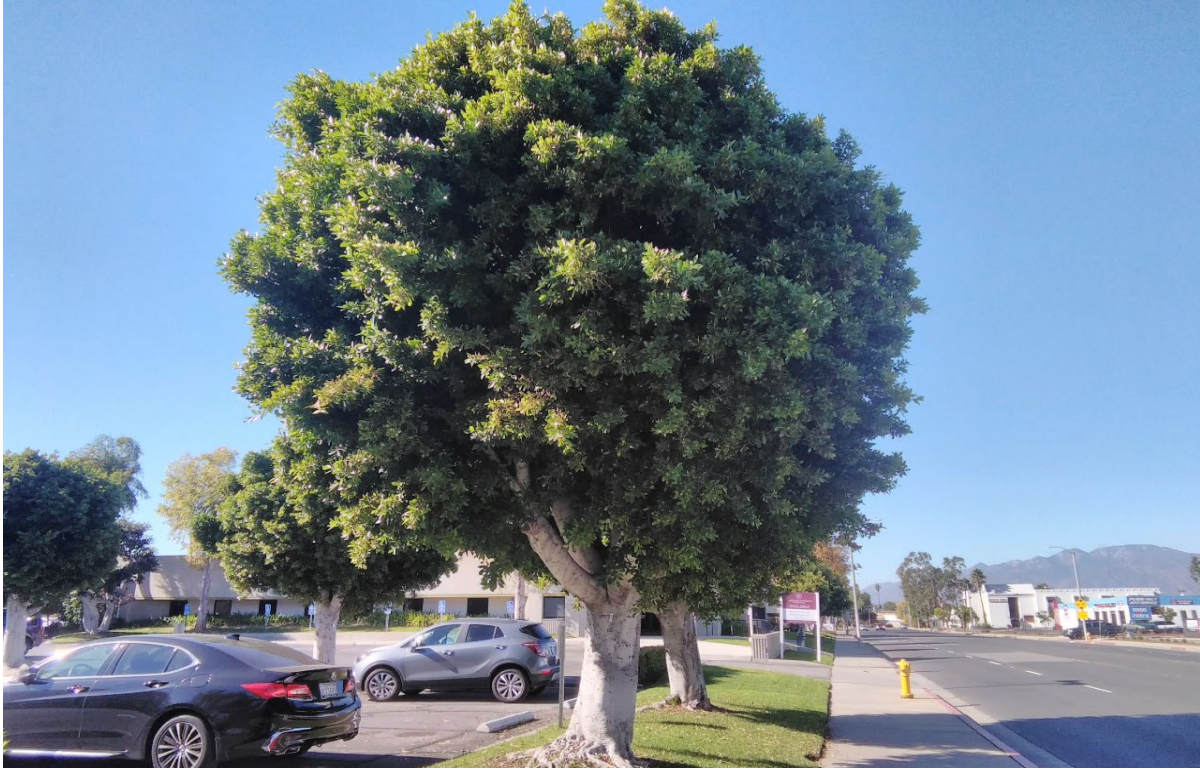
Photograph 3. Tree 34, little-leaf fig (*Ficus microcarpa*). City Significant Tree.

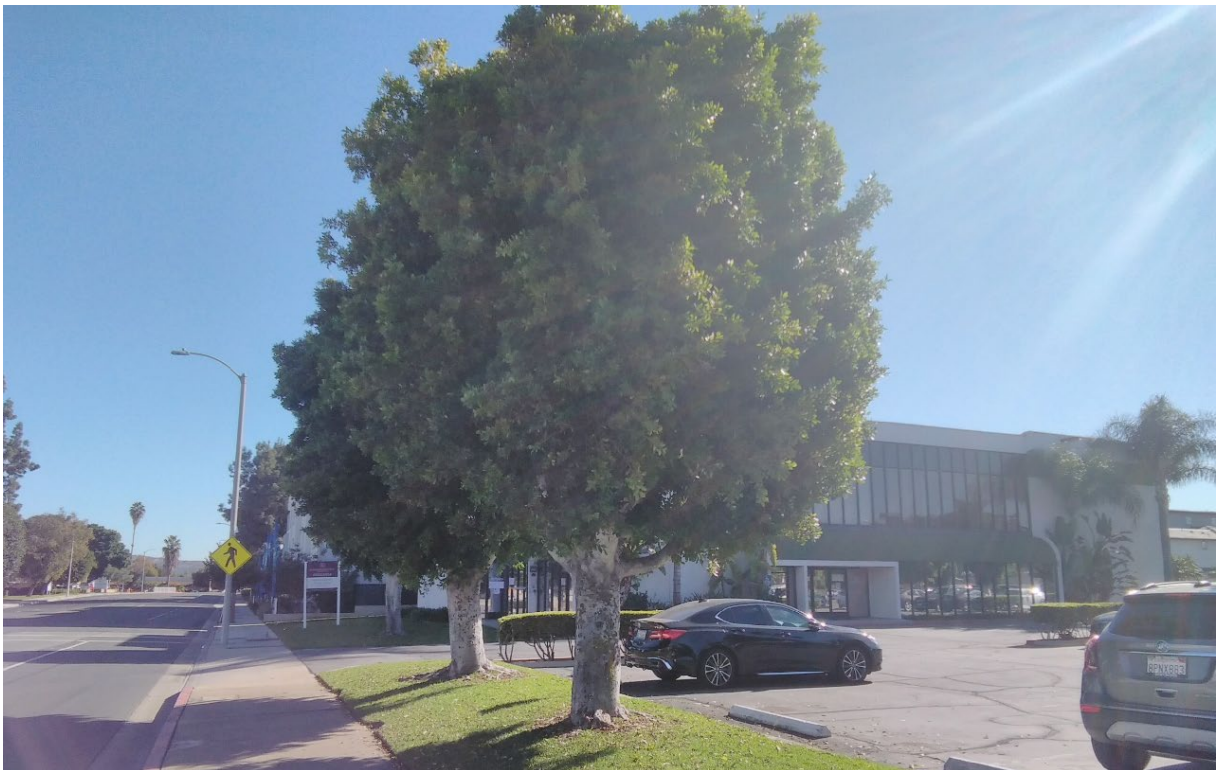
Photograph 4. Tree 35, little-leaf fig (*Ficus microcarpa*). City Significant Tree.

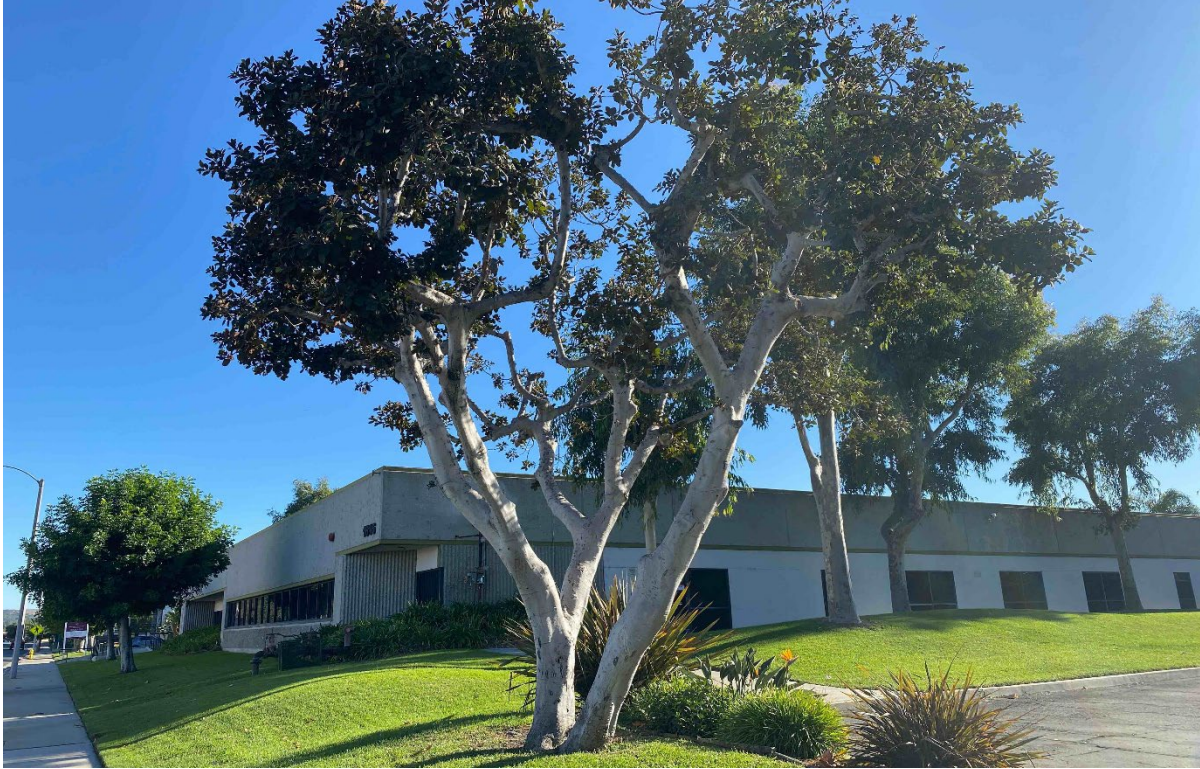
Photograph 5. Tree 59, banyan fig (*Ficus benghalensis*). City Significant Tree.

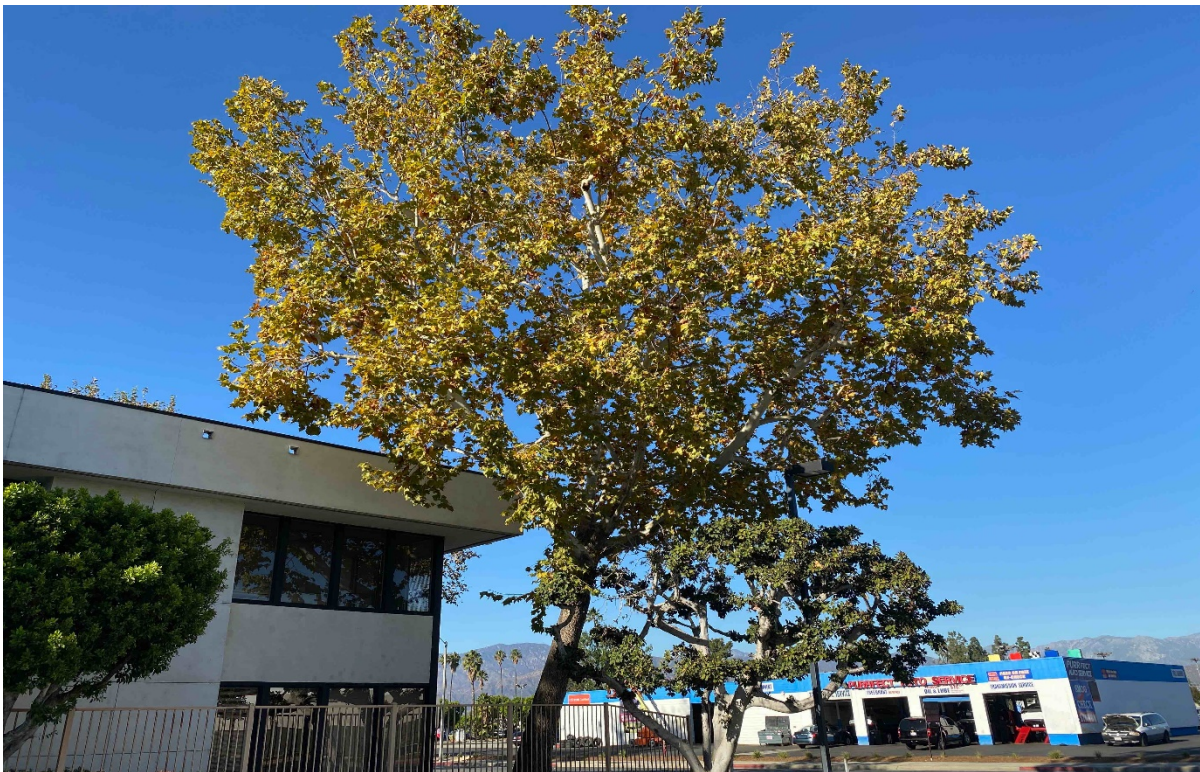
Photograph 6. Tree 70, California sycamore (*Platanus racemosa*). City Significant Tree.

The following measures are recommended to avoid and minimize impacts to the overhanging California sycamore, a significant tree not proposed for removal. The planning director may impose additional measures determined necessary to preserve and protect the health of trees not planned for removal.

- The California sycamore should be shielded from damage during construction with an appropriate construction barrier, such as chain link and steel stake fence enclosing the entire dripline area. All exposed roots should be inside the fence or barrier. The fence or barrier should have a minimum height of six (6) feet measured from the grade. The fence or barrier should be installed prior to commencement of any development activity on the site and should remain in place throughout all phases of construction. Fences may not be removed without obtaining written authorization from the planning director.

- Compaction of the soil within the dripline of the California sycamore should be minimized to the greatest extent feasible.
- No cutting of roots should occur within a distance equal to three and one-half (3½) times the trunk diameter, as measured at ground level. The trunk diameter of the California sycamore is 26 inches; accordingly, the appropriate root avoidance distance is at least 7.5 feet from the trunk. Any roots encountered within the dripline should be cleanly cut with a sharp cutting tool such as a lopping shear or hand saw and not ripped by equipment.
