City of West Covina
Historic Resource Inventory Update

Attachment 2

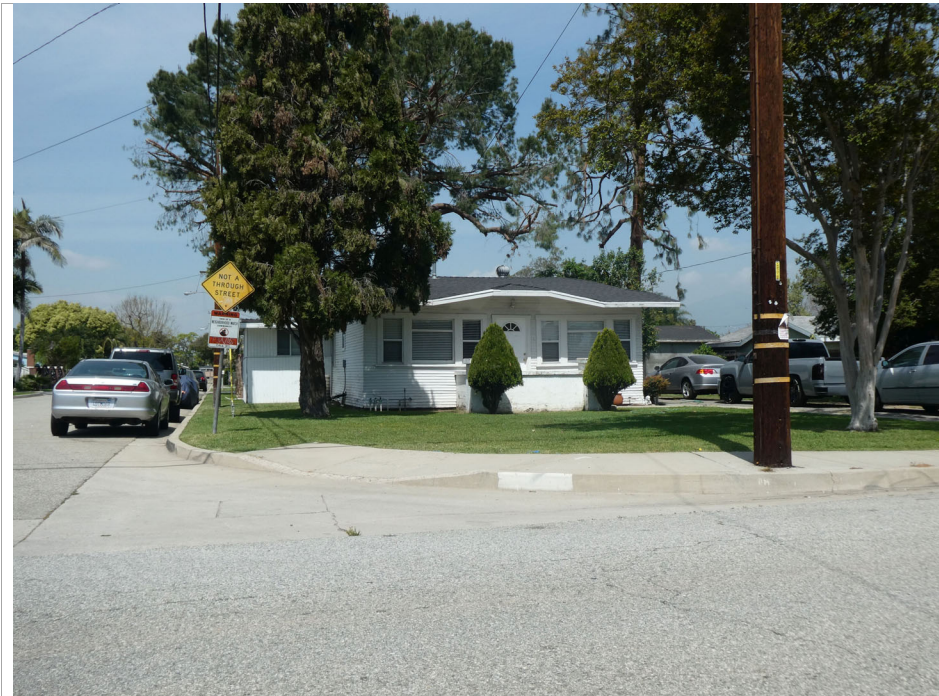
*Resource Name or #: 153 N. Willow Ave.

The property does not appear to have been substantially altered since it was evaluated in the 2006 survey. No changes are proposed to the status code assigned in 2006.

P5b Description/Date of Photo Southeast elevation, view facing northwest/2019

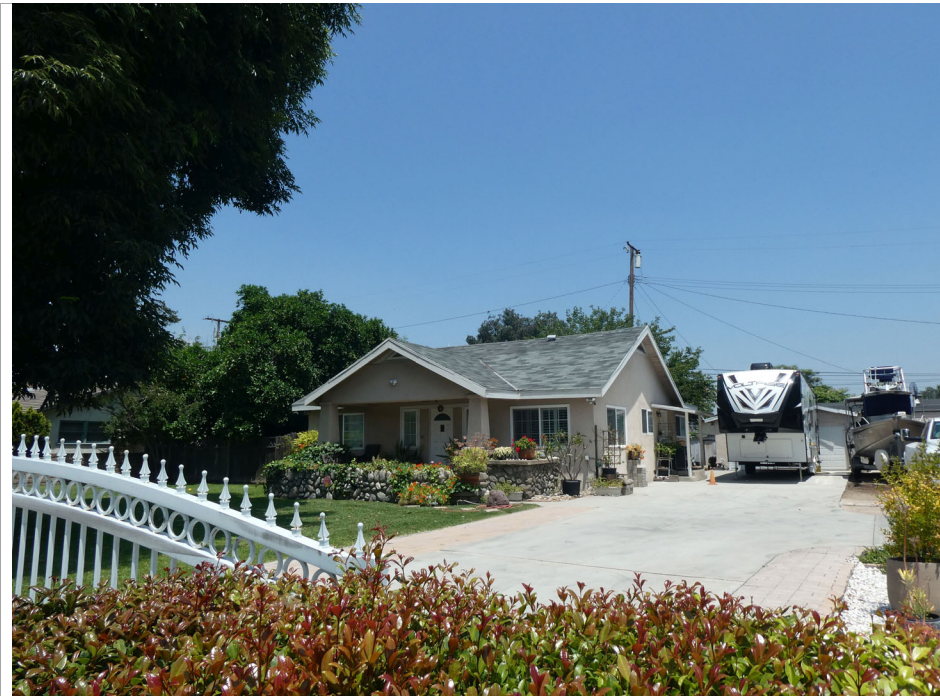
*Resource Name or #: 206 N. Orange Ave.

The residence on the property appears to have been substantially altered. Alterations include: resizing original window openings, the replacement of original windows, incompatible changes to front entrance, and re-cladding with an incompatible material. The property does not retain sufficient integrity to be eligible for listing in the National Register, the California Register, or for local designation.

P5b Description/Date of Photo West elevation, view facing northeast/2019

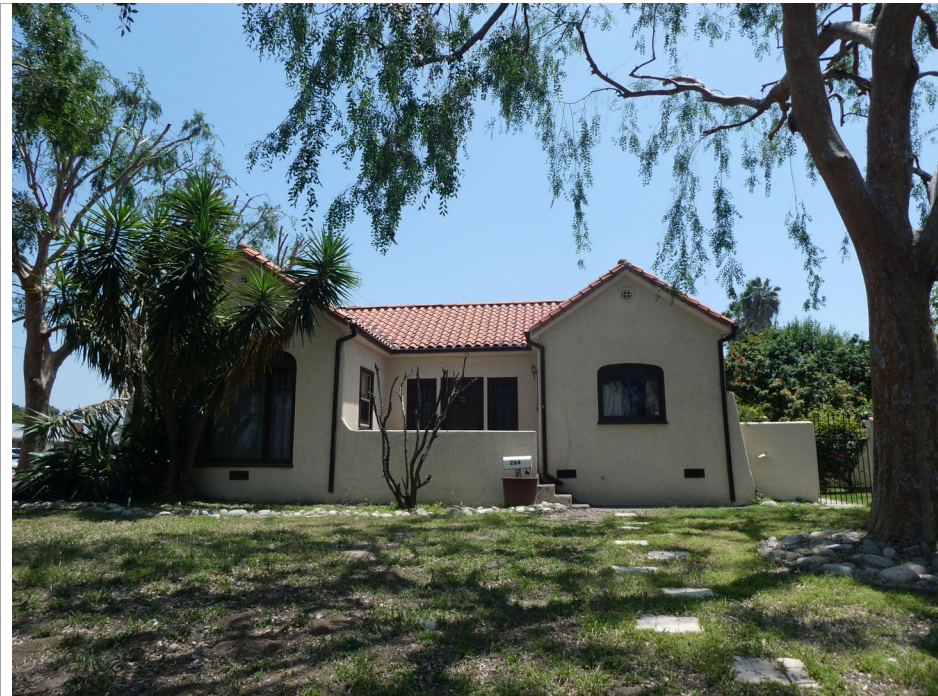
***Resource Name or #:** 264 N. Willow Ave.

The property does not appear to have been substantially altered since it was evaluated in the 2006 survey. No changes are proposed to the status code assigned in 2006.

P5b Description/Date of Photo Northwest elevation, view facing southeast/2019

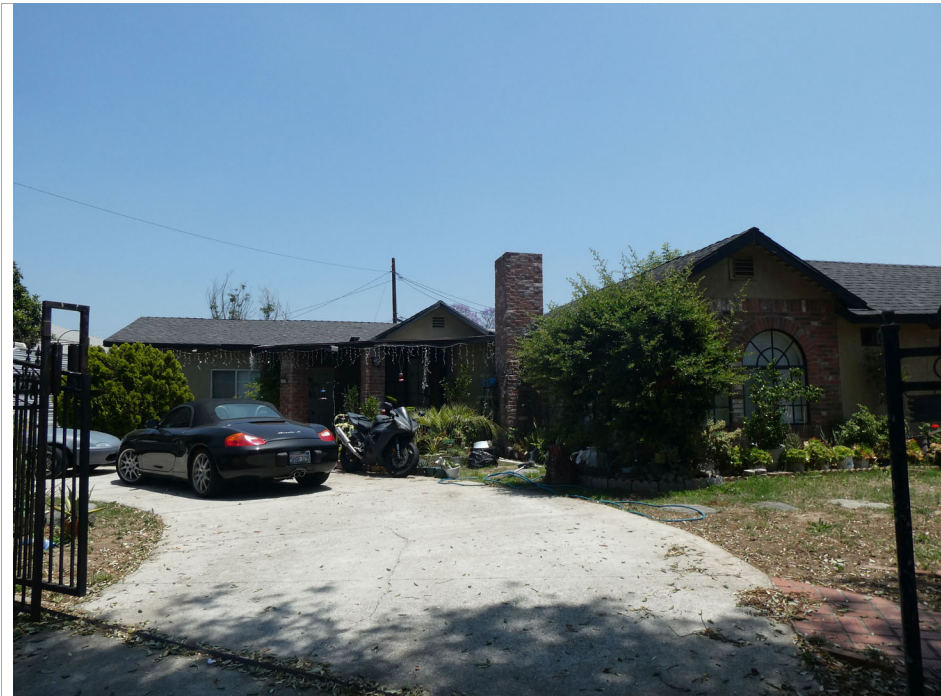
P5b Description/Date of Photo Northwest elevation, view facing southeast/2019

The property was evaluated as ineligible for listing in the National Register, the California Register, or for local designation in 2006. No changes are proposed to the status code assigned in 2006.

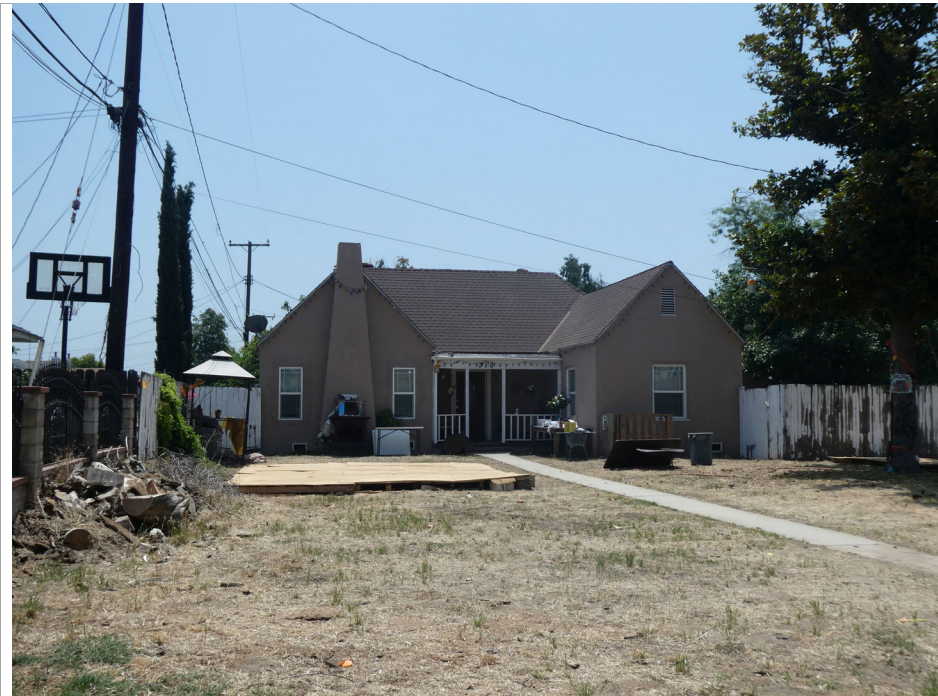
*Resource Name or #: 310 N. Puente Ave.

The property does not appear to have been substantially altered since it was evaluated in the 2006 survey. No changes are proposed to the status code assigned in 2006.

P5b Description/Date of Photo Northwest elevation, view facing southeast/2019

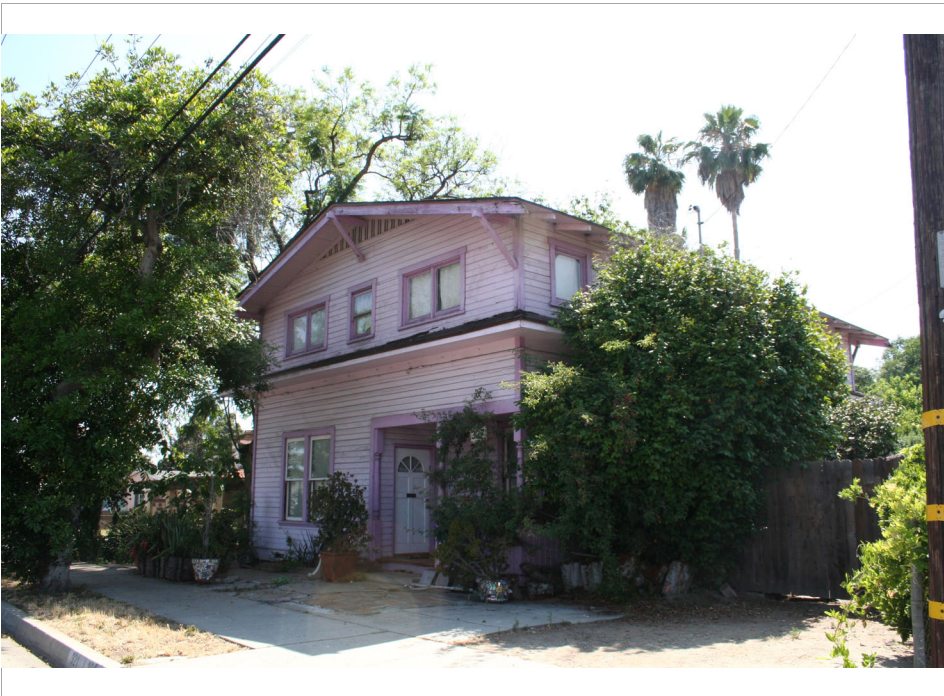
***Resource Name or #:** 321 and 327 N. Sunset Ave.

The residence at 327 N. Sunset Ave does not appear to have been substantially altered since it was evaluated in the 2006 survey. A second residence not visible from the public right-of-way may be associated with address 321 N. Sunset Avenue. This residence could not be evaluated. However, because the visible residence on the property does not appear substantially altered since the previous survey, no changes are proposed to the status code assigned in 2006.

P5b Description/Date of Photo East elevation, view facing southwest/2019

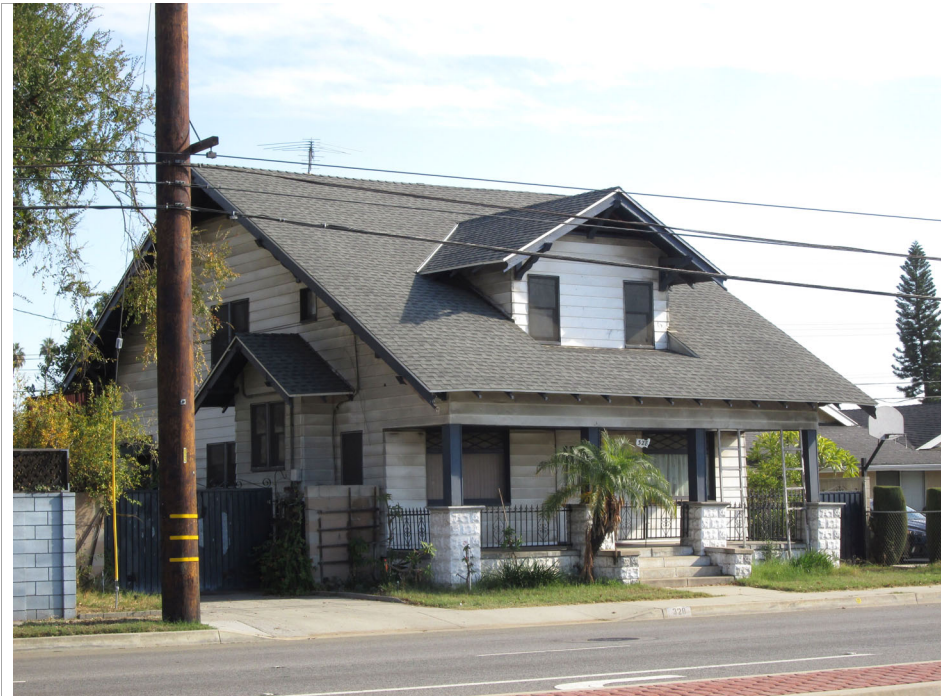
P5b Description/Date of Photo West elevation, view facing southeast/2018

The property does not appear to have been substantially altered since it was evaluated in the 2006 survey. No changes are proposed to the status code assigned in 2006.

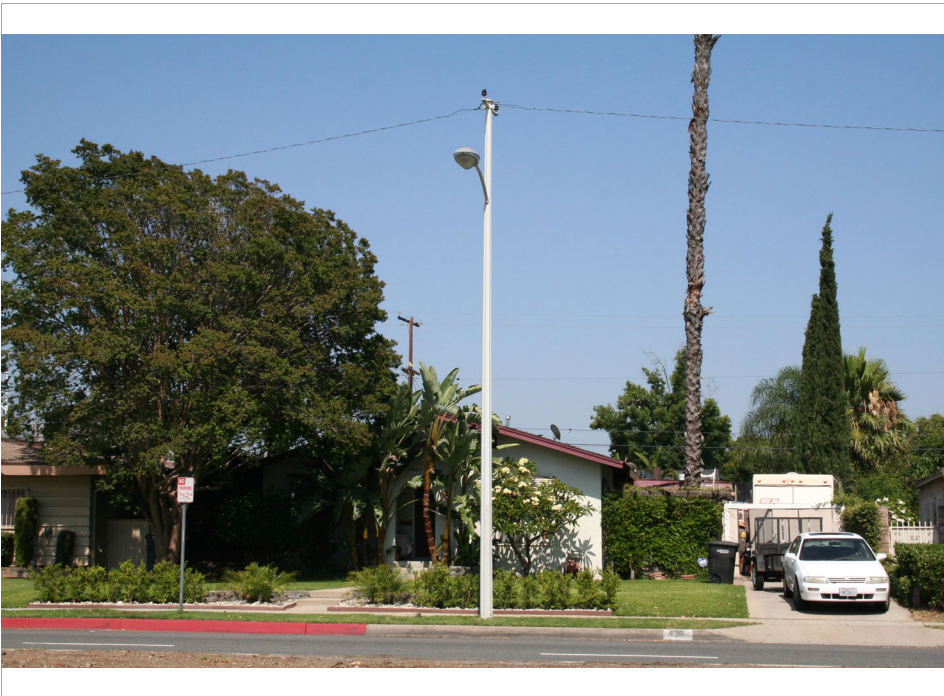
P5b Description/Date of Photo West elevation, view facing east/2019

The property does not appear to have been substantially altered since it was evaluated in the 2006 survey. No changes are proposed to the status code assigned in 2006.

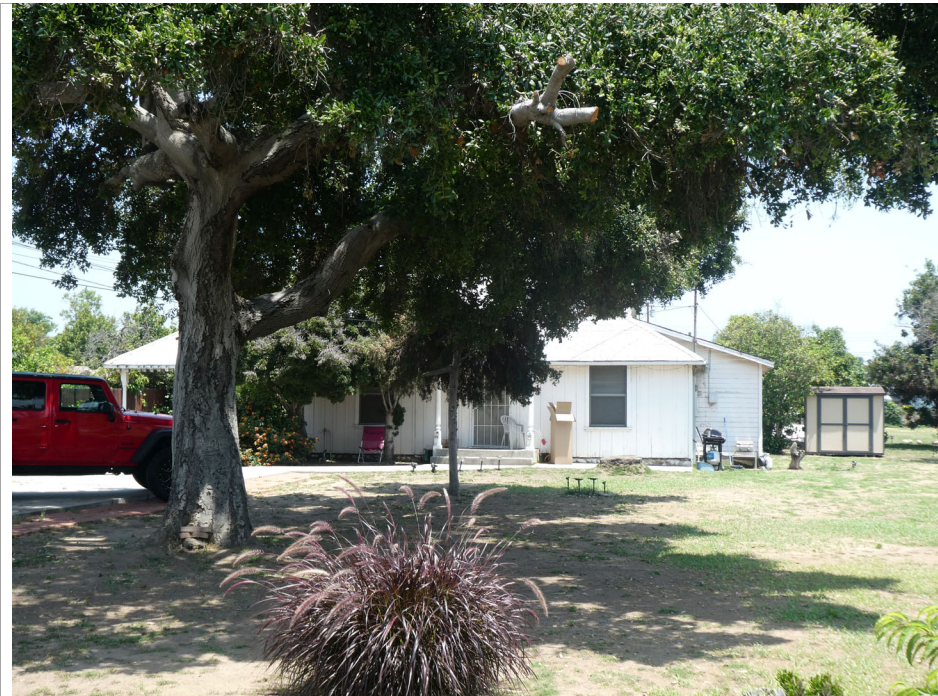
P5b Description/Date of Photo West elevation, view facing east/2019

The property does not appear to have been substantially altered since it was evaluated in the 2006 survey. No changes are proposed to the status code assigned in 2006.

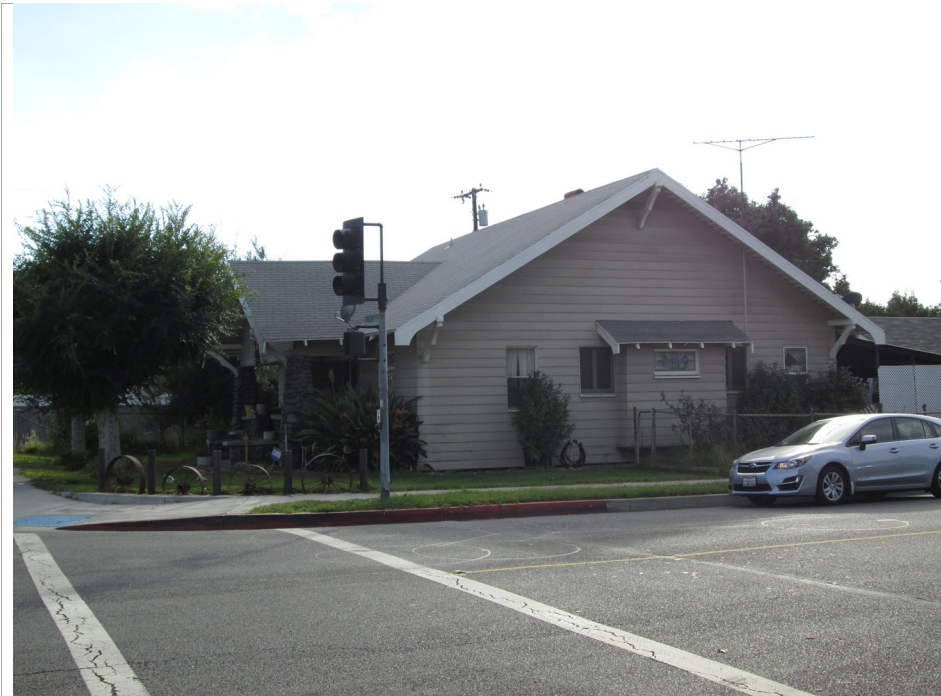
P5b Description/Date of Photo North elevation, view facing southwest/2018

The property does not appear to have been substantially altered since it was evaluated in the 2006 survey. No changes are proposed to the status code assigned in 2006.

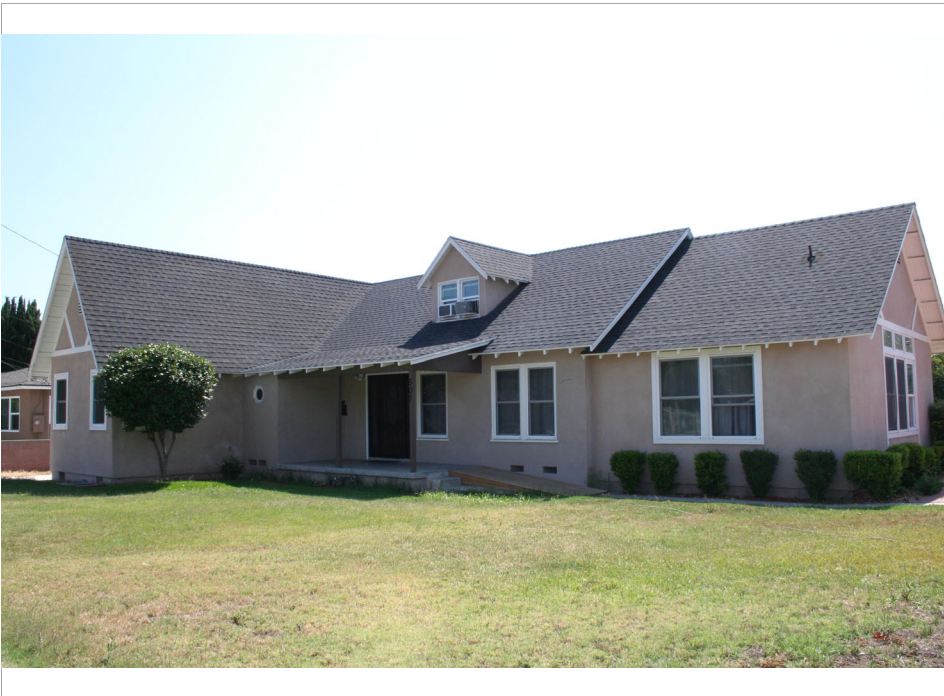
***Resource Name or #:** 507 N. Sunset Ave.

The residence on the property appears to have been substantially altered since it was evaluated in the 2006 survey. Alterations include: replacement of original windows with vinyl sash and incompatible changes to front entrance. The property does not retain sufficient integrity to be eligible for listing in the National Register, the California Register, or for local designation.

P5b Description/Date of Photo East elevation, view facing southwest/2019

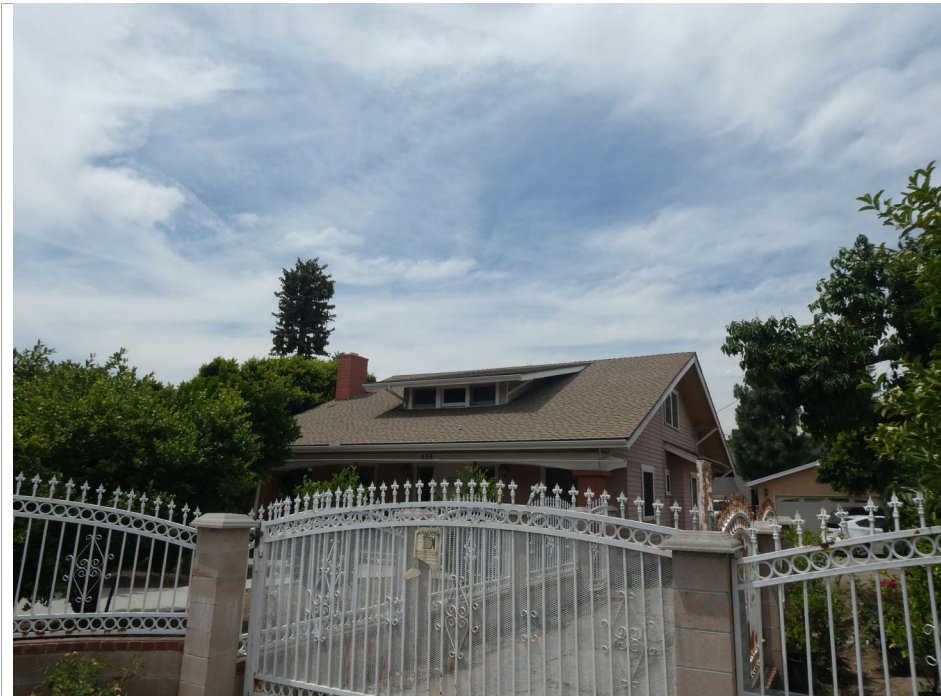
P5b Description/Date of Photo South elevation, view facing northwest/2019

The property does not appear to have been substantially altered since it was evaluated in the 2006 survey. No changes are proposed to the status code assigned in 2006.

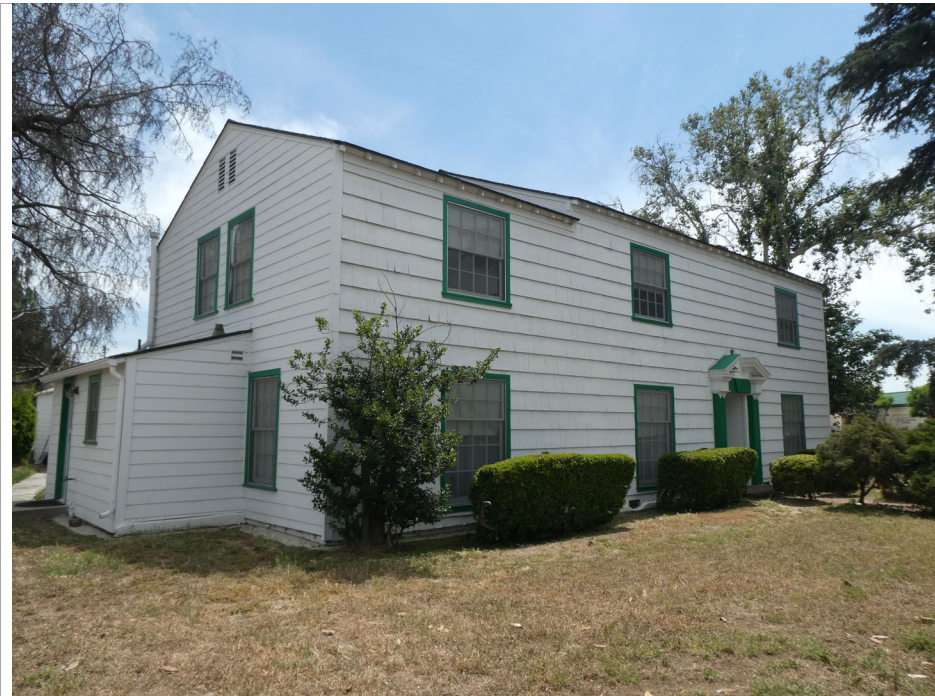
P5b Description/Date of Photo North elevation, view facing southwest/2019

The property does not appear to have been substantially altered since it was evaluated in the 2006 survey. No changes are proposed to the status code assigned in 2006.

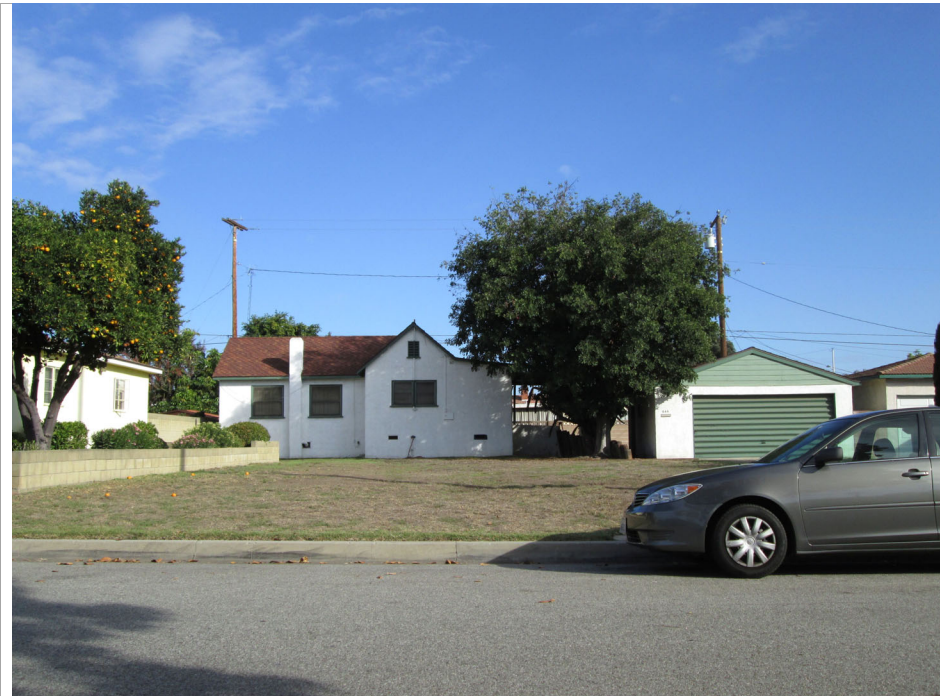
P5b Description/Date of Photo West elevation, view facing east/2018

The property does not appear to have been substantially altered since it was evaluated in the 2006 survey. No changes are proposed to the status code assigned in 2006.

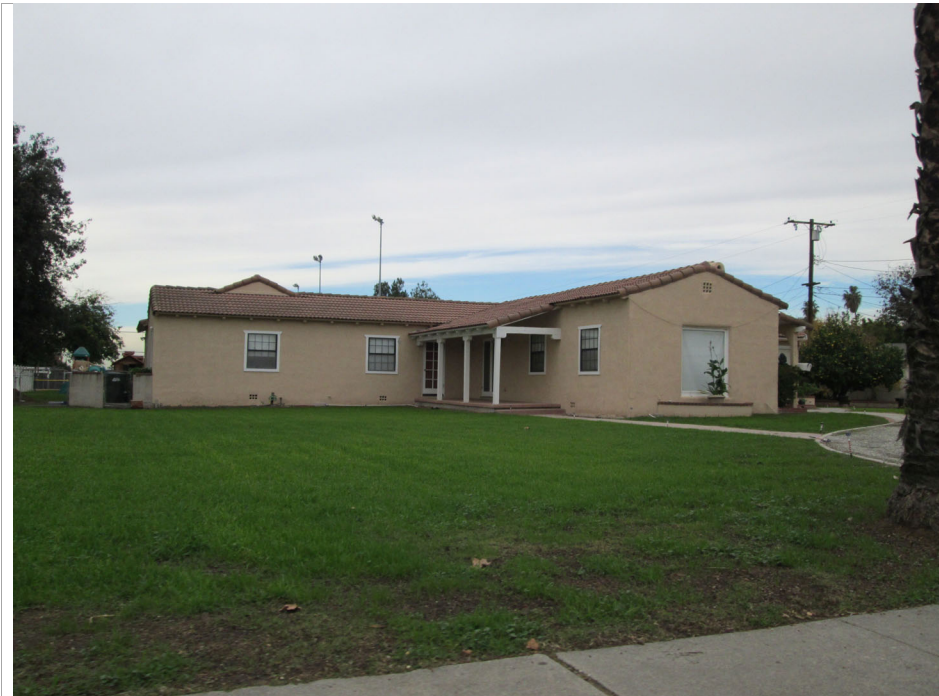
***Resource Name or #:** 707 S. Lark Ellen Ave.

The property does not appear to have been substantially altered since it was evaluated in the 2006 survey. The status code assigned in 2006 was 7N1 with the condition that the residence would be eligible for the National Register and California Register if it was restored; however, the restoration work was not specified in 2006. In 2018, the property did not appear to be substantially different from its previous appearance. The proposed status code for this update is 7N.

P5b Description/Date of Photo East elevation, view facing northwest/2018

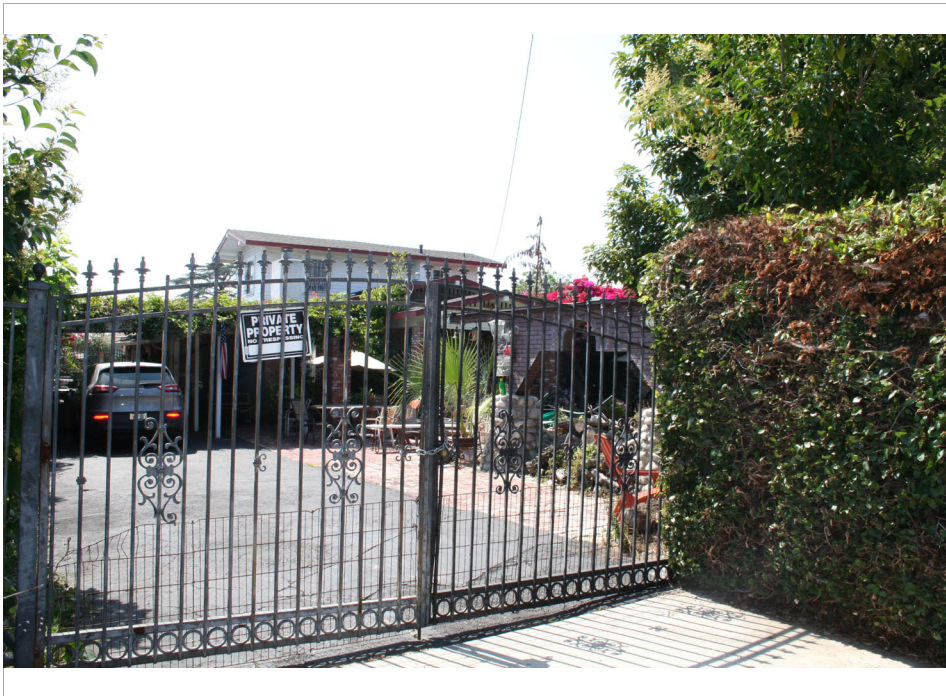
P5b Description/Date of Photo East elevation, view facing west/2019

The property is not visible from the public right-of-way. Further evaluation is needed to determine if it remains eligible for listing in the National Register, the California Register, and for local designation.

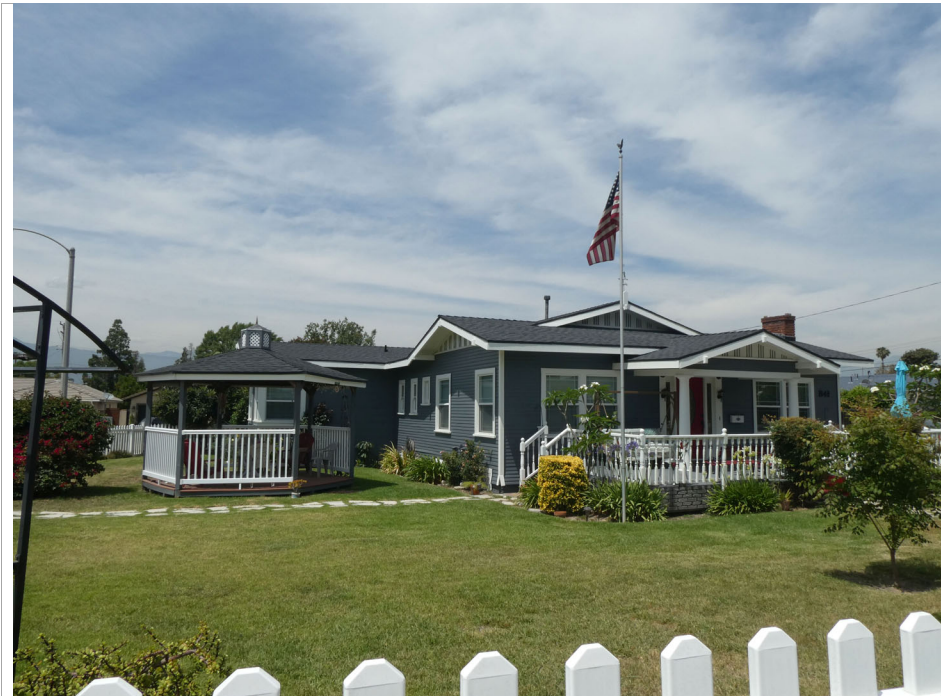
***Resource Name or #:** 841 E. Vine Ave.

The property does not appear to have been substantially altered since it was evaluated in the 2006 survey. The status code assigned in 2006 was 7N1 with the condition that the residence would be eligible for the National Register and California Register if it was restored; however, the restoration work was not specified in 2006. In 2018, the property did not appear to be substantially different from its previous appearance. The proposed status code for this update is 7N.

P5b Description/Date of Photo South elevation, view facing northeast/2019

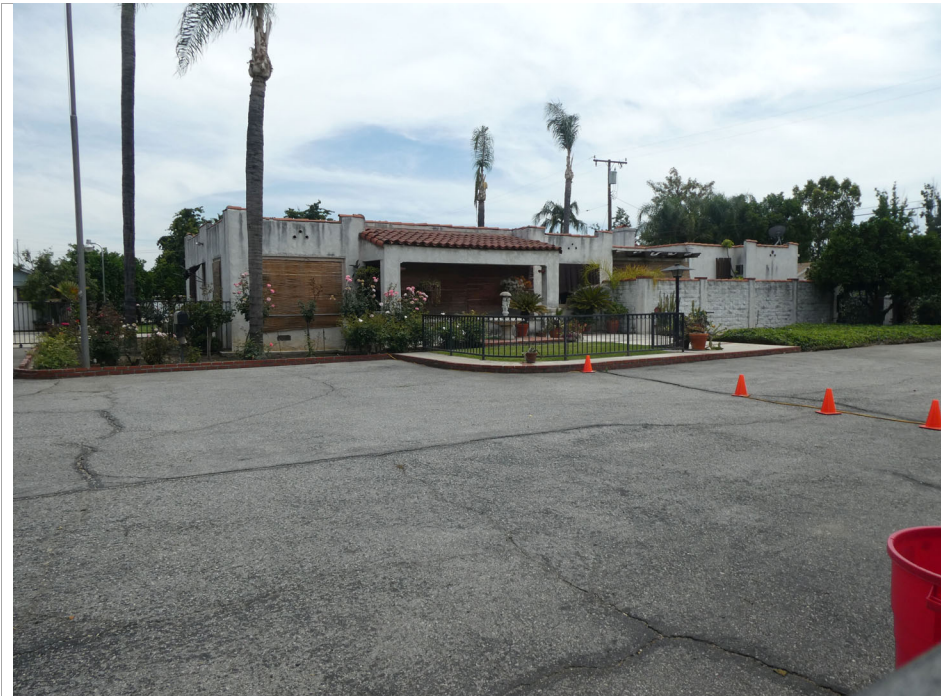
P5b Description/Date of Photo Northwest elevation, view facing south/2019

The property is not fully visible from the public right-of-way. Further evaluation is needed to determine if it remains eligible for listing in the National Register, the California Register, and for local designation.

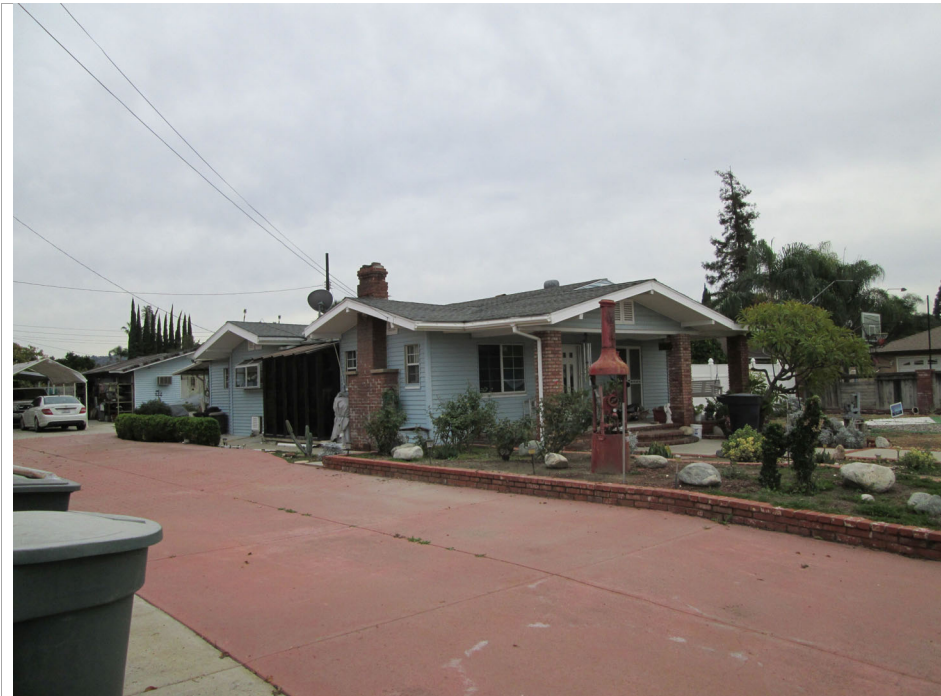
P5b Description/Date of Photo West elevation, view facing southeast/2018

The property does not appear to have been substantially altered since it was evaluated in the 2006 survey. No changes are proposed to the status code assigned in 2006.

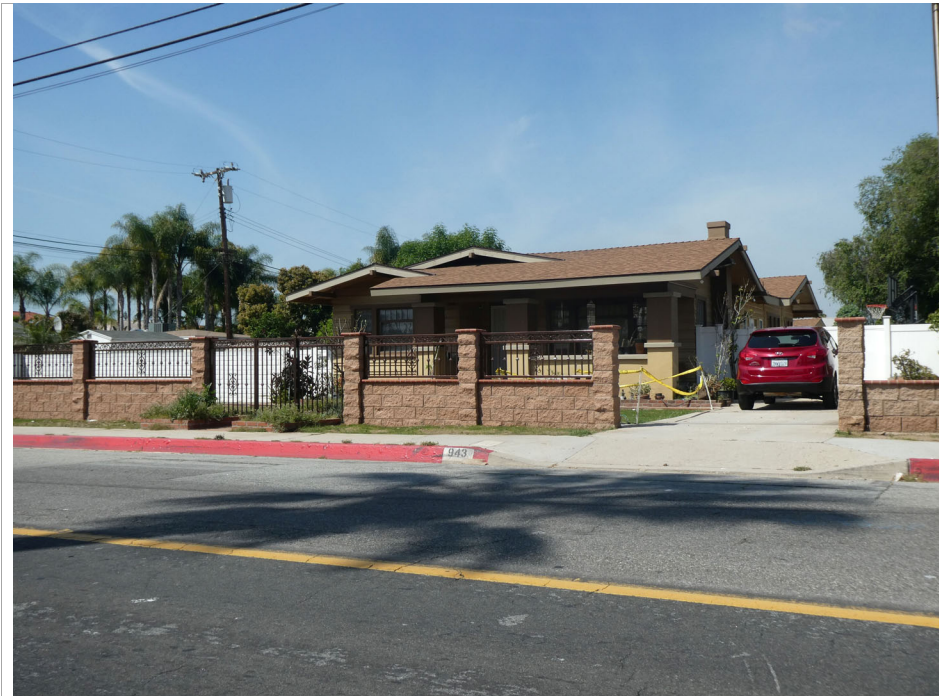
P5b Description/Date of Photo East elevation, view facing southwest/2019

The property does not appear to have been substantially altered since it was evaluated in the 2006 survey. No changes are proposed to the status code assigned in 2006.

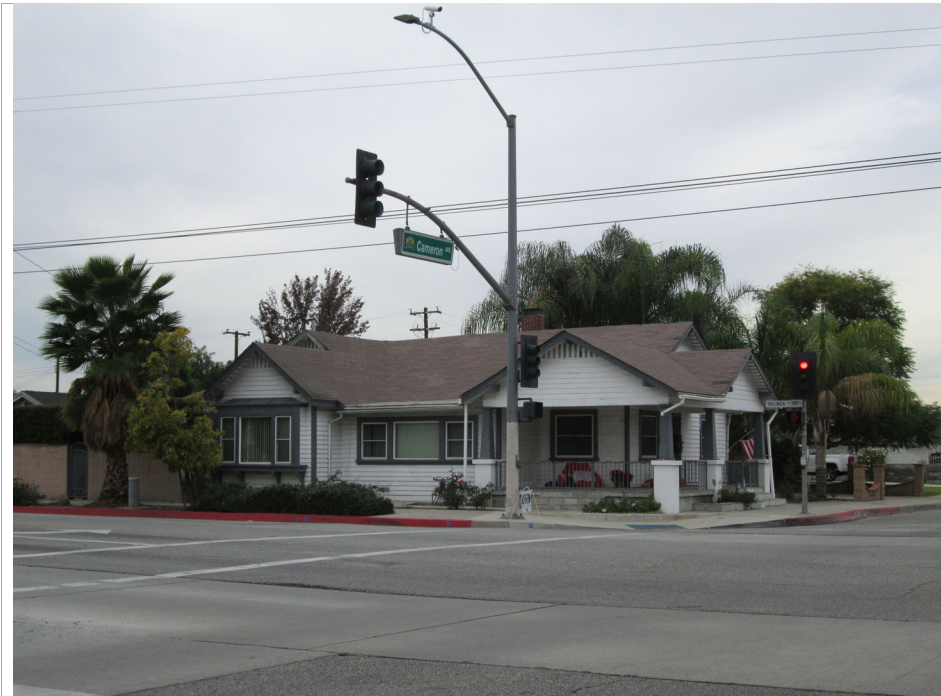
*Resource Name or #: 944 East Cameron Avenue

The property does not appear to have been substantially altered since it was evaluated in the 2006 survey. Original windows have been replaced, but the sizing has not been altered. No changes are proposed to the status code assigned in 2006.

P5b Description/Date of Photo East elevation, view facing southwest/2018

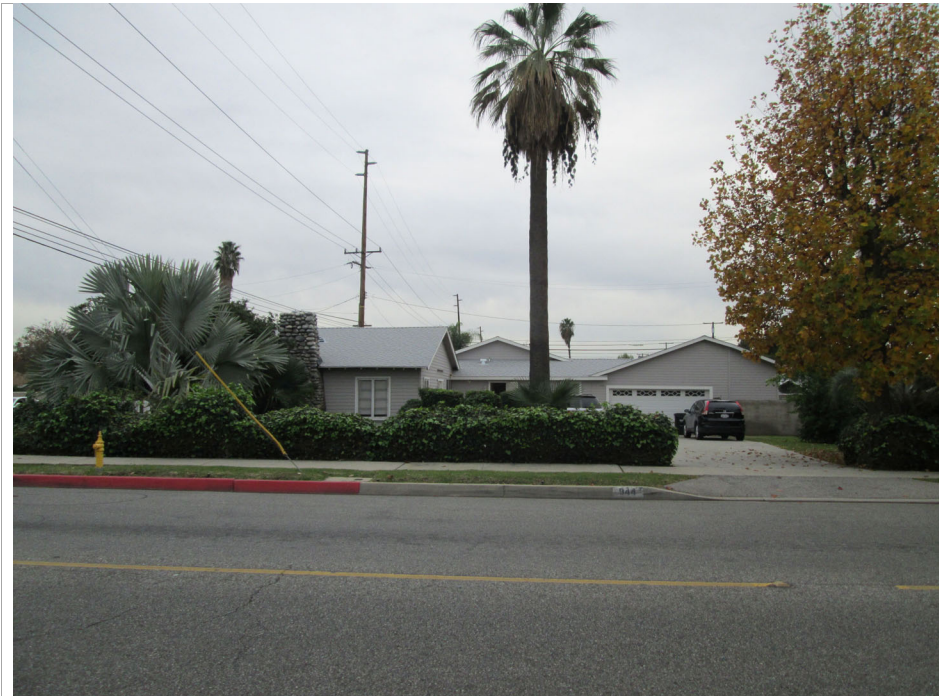
***Resource Name or #:** 944 E. Vine Ave.

The property does not appear to have been substantially altered since it was evaluated in the 2006 survey. Alterations include a rear addition separate from the historic residence. Decorative features including shutters have been removed, but these features may not have been original to the residence. No changes are proposed to the status code assigned in 2006.

P5b Description/Date of Photo North elevation, view facing south/2018

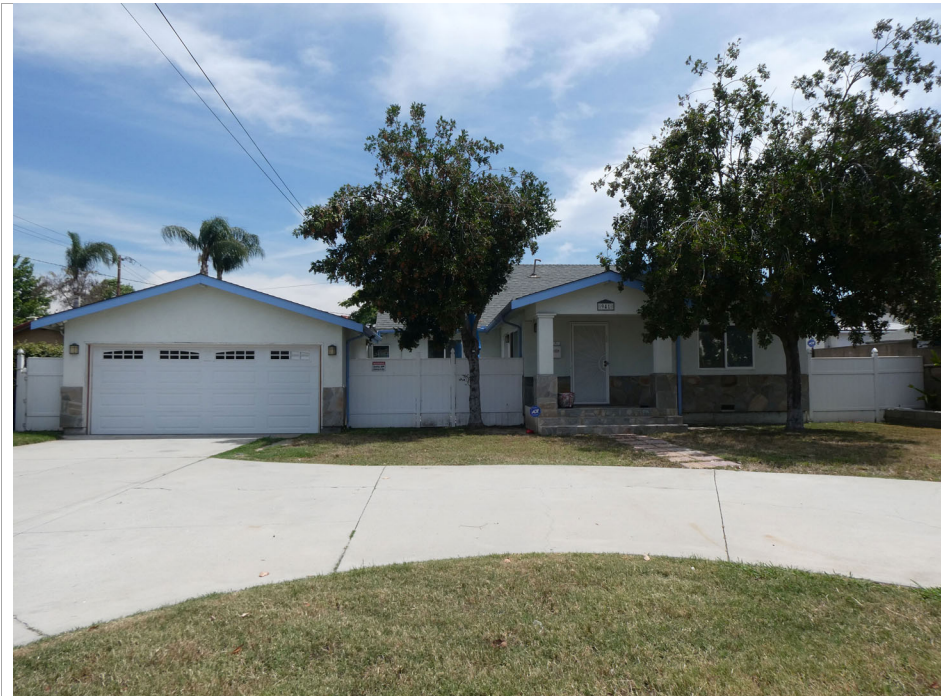
***Resource Name or #:** 941 W. Merced Ave.

The residence on the property appears to have been substantially altered since it was evaluated in the 2006 survey. Alterations include: resizing original window openings, the replacement of original windows, and incompatible changes to front entrance. The property does not retain sufficient integrity to be eligible for listing in the National Register, the California Register, or for local designation.

P5b Description/Date of Photo Southwest elevation, view facing northeast/2019

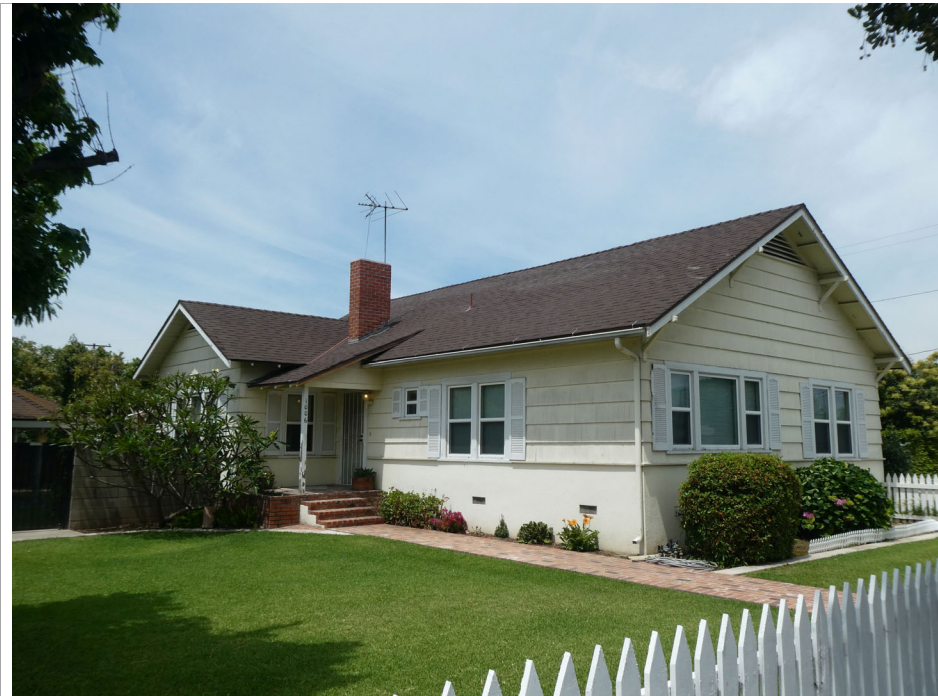
P5b Description/Date of Photo Southeast elevation, view facing west/2019

The property does not appear to have been substantially altered since it was evaluated in the 2006 survey. No changes are proposed to the status code assigned in 2006.

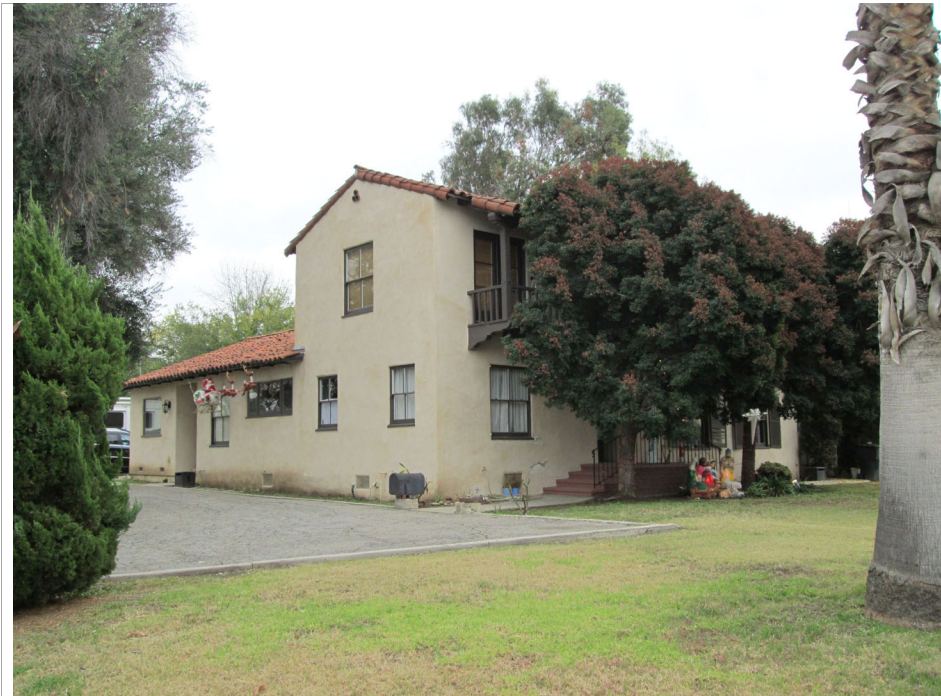
*Resource Name or #: 1006 S. Lark Ellen Ave.

The evaluation in 2006 noted that the property had been substantially altered; however, no substantial alterations were observed 2018. The property appears to retain sufficient integrity comparable to other West Covina properties determined eligible for listing in the National Register, the California Register, or for local designation as part of the survey in 2006. The proposed status code of 3S/3CS/5S3 mirrors evaluations of similarly intact properties evaluated in 2006.

P5b Description/Date of Photo West elevation, view facing southeast/2018

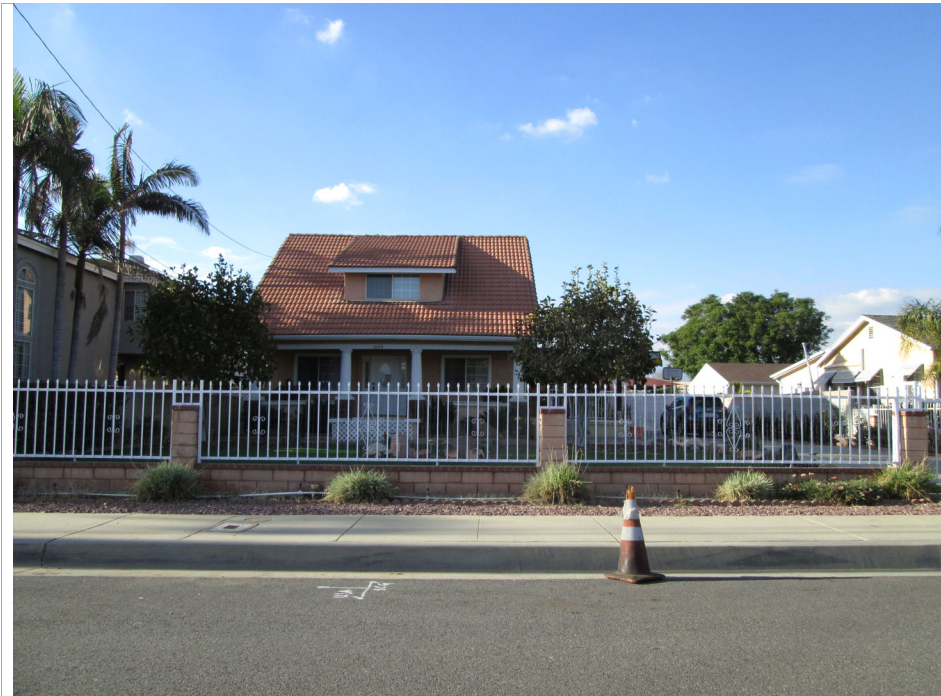
The residence on the property appears to have been substantially altered. Alterations include: resizing original window openings, the replacement of original windows, incompatible changes to front entrance, and re-cladding with an incompatible material. The property does not retain sufficient integrity to be eligible for listing in the National Register, the California Register, or for local designation.

P5b Description/Date of Photo Southeast elevation, view facing northwest/2018

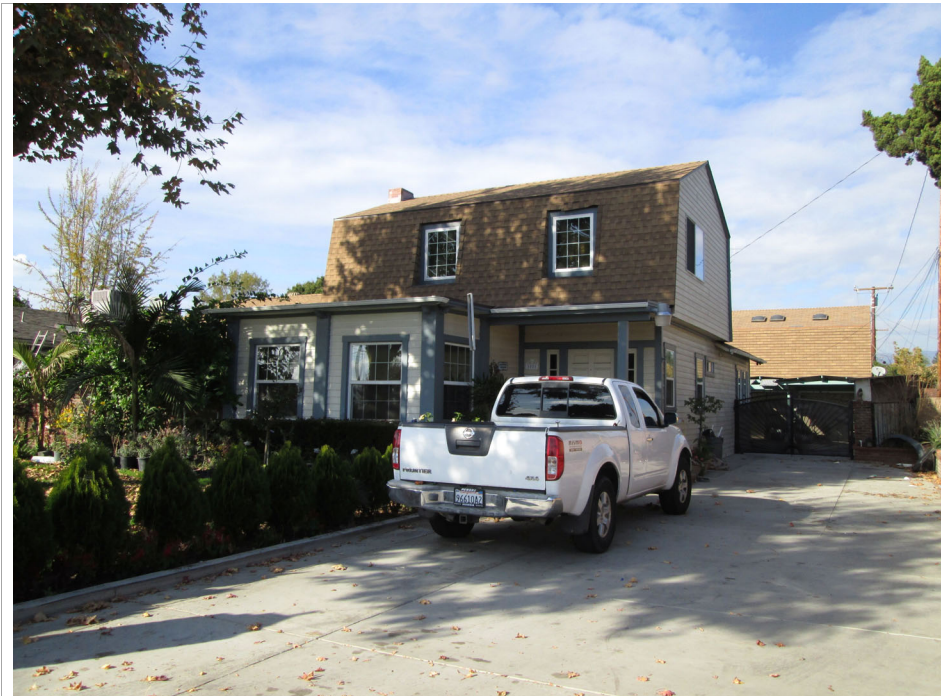
P5b Description/Date of Photo South elevation, view facing northwest/2018

The property does not appear to have been substantially altered since it was evaluated in the 2006 survey. No changes are proposed to the status code assigned in 2006.

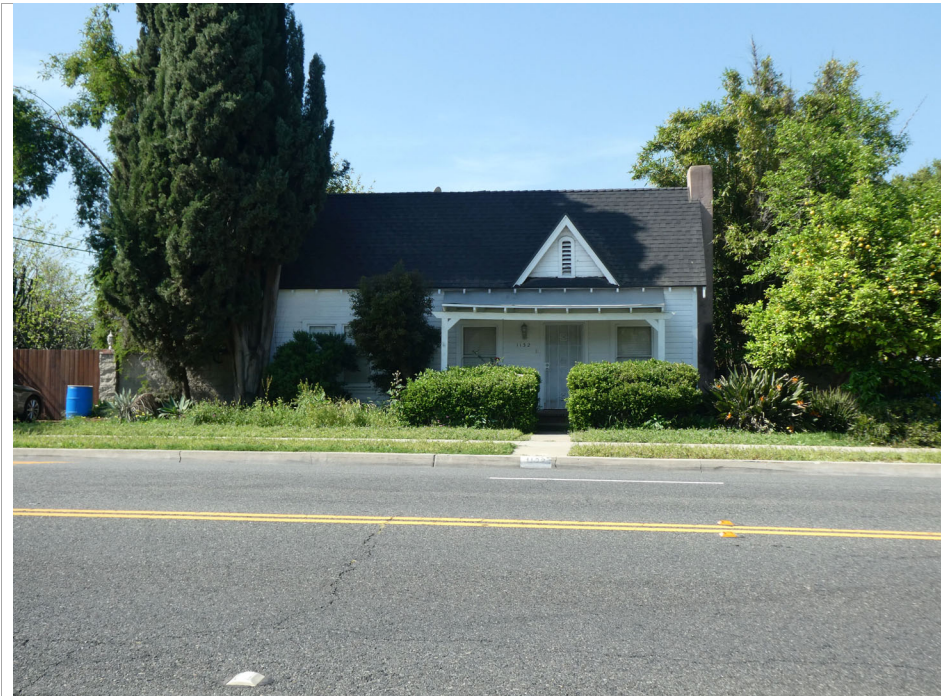
P5b Description/Date of Photo Northeast elevation, view facing southwest/2019

The property does not appear to have been substantially altered since it was evaluated in the 2006 survey. No changes are proposed to the status code assigned in 2006.

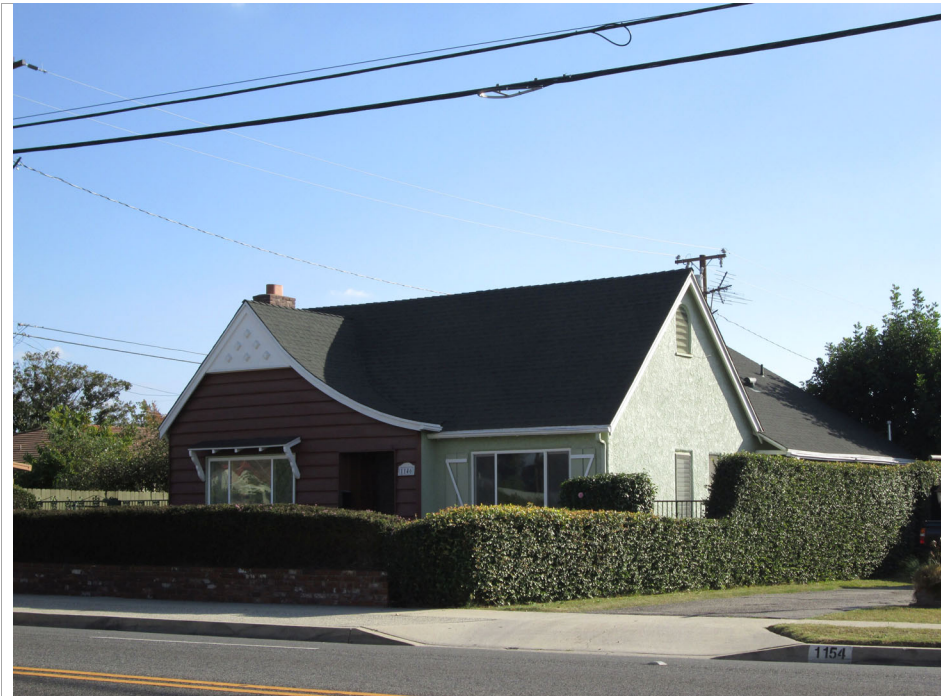
The evaluation in 2006 noted that the property was not eligible because it had been moved from its original location. While the property may not be eligible for the National Register because it does not meet Criteria Consideration B for moved properties, the property appears to retain sufficient integrity comparable to other West Covina properties determined eligible for listing in the California Register and for local designation in 2006. The recommended status code change reflects this eligibility.

P5b Description/Date of Photo North elevation, view facing southeast/2018

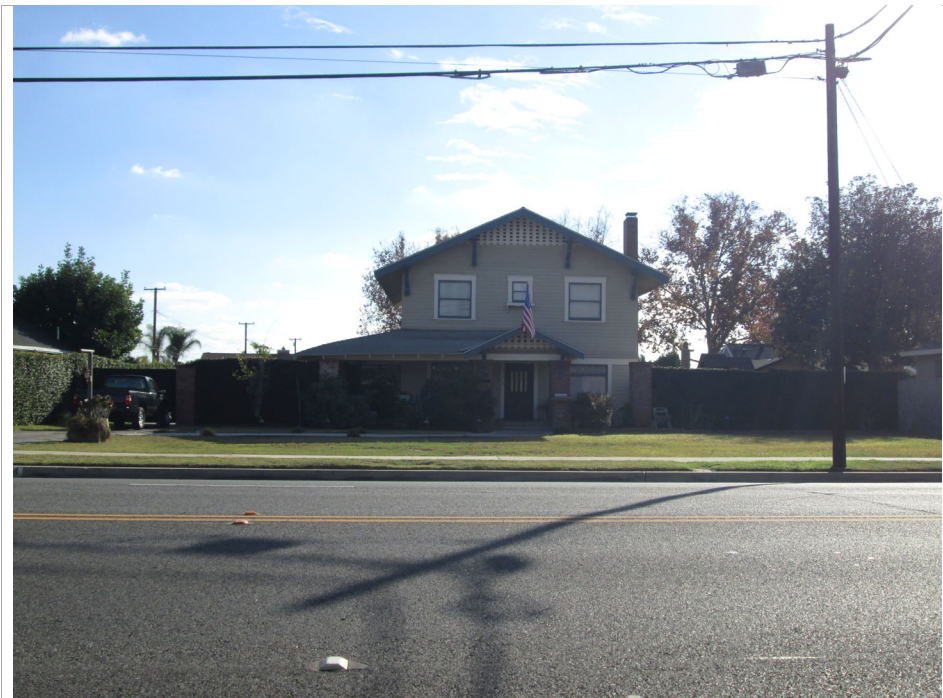
P5b Description/Date of Photo North elevation, view facing south/2018

The property does not appear to have been substantially altered since it was evaluated in the 2006 survey. No changes are proposed to the status code assigned in 2006.
