City of West Covina
Historic Resource Inventory Update

Attachment 2

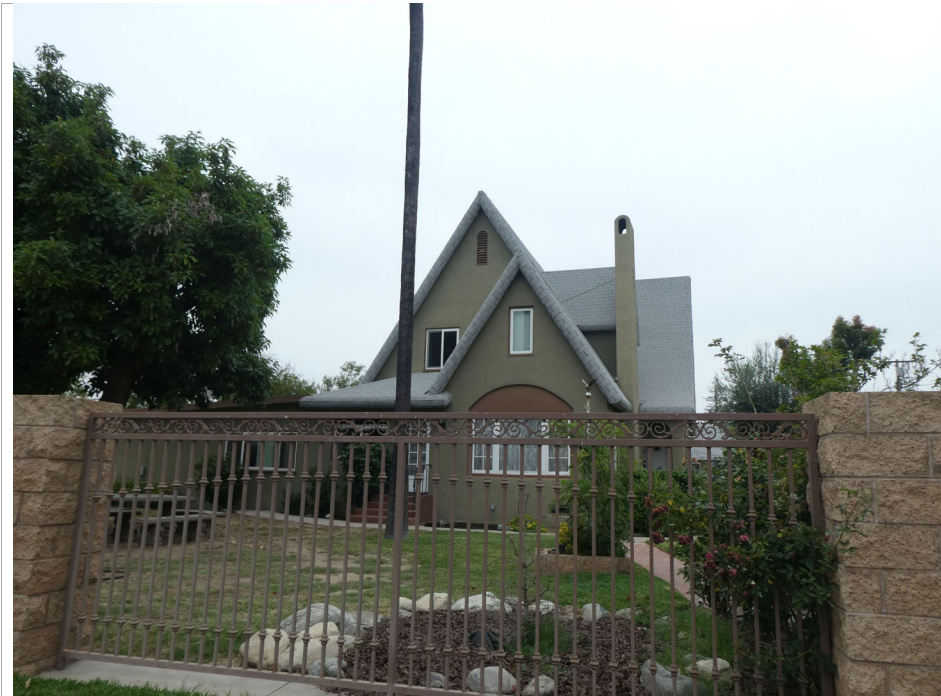
P5b Description/Date of Photo South elevation, view facing north/2019

The property does not appear to have been substantially altered since it was evaluated in the 2006 survey. No changes are proposed to the status code assigned in 2006.

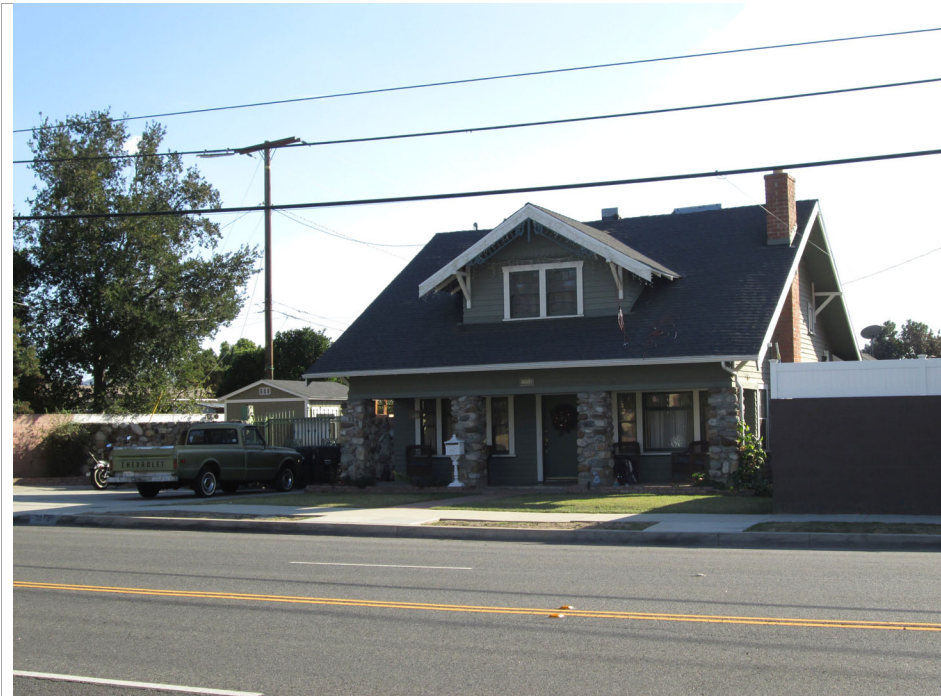
P5b Description/Date of Photo North elevation, view facing southeast/2018

The property does not appear to have been substantially altered since it was evaluated in the 2006 survey. No changes are proposed to the status code assigned in 2006.

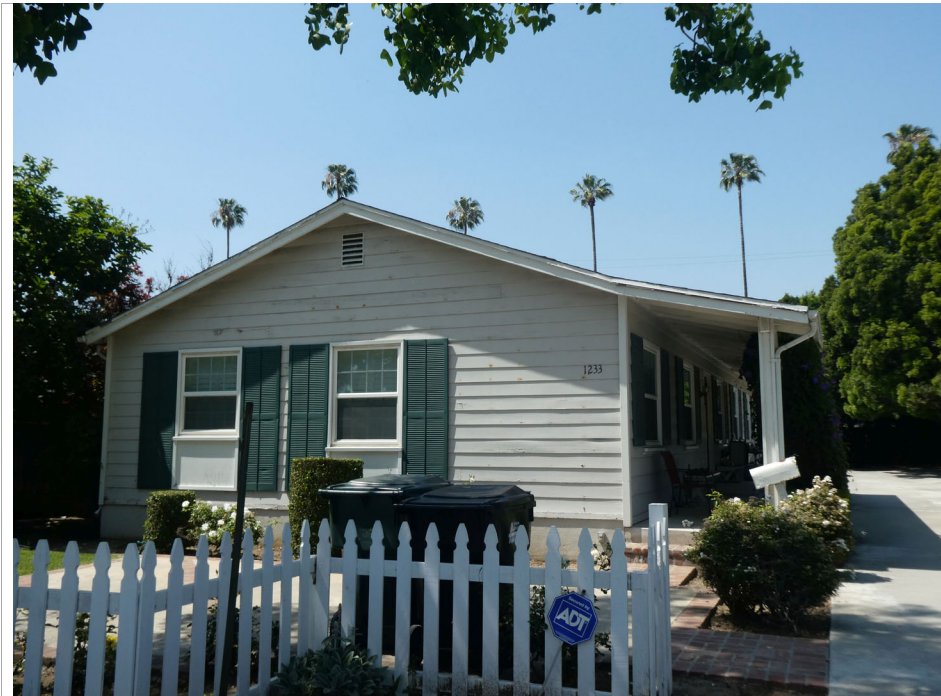
P5b Description/Date of Photo South elevation, view facing north/2019

The property does not appear to have been substantially altered since it was evaluated in the 2006 survey. No changes are proposed to the status code assigned in 2006.

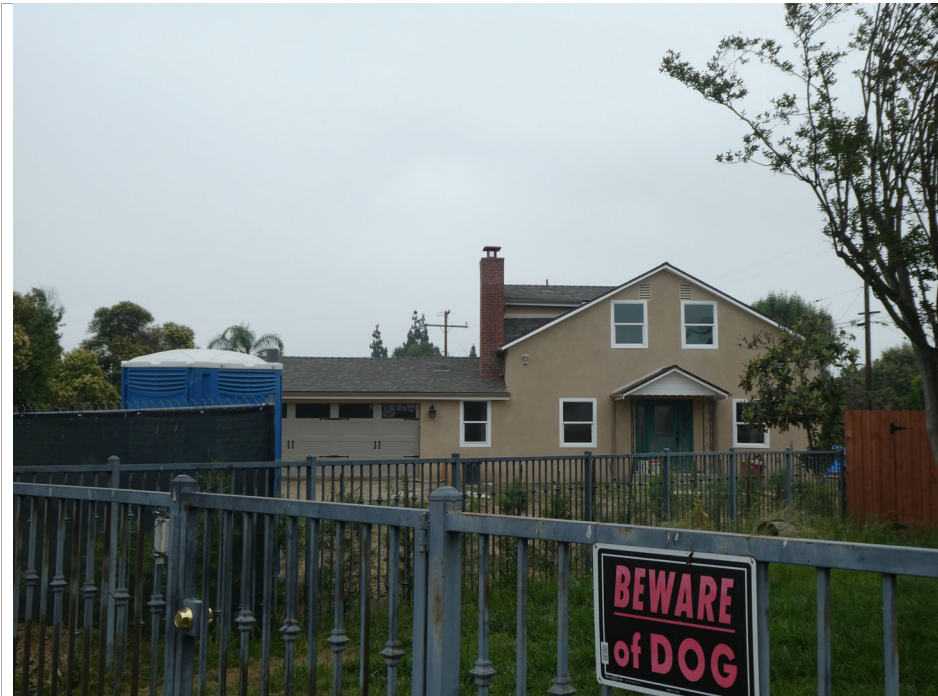
The residence on the property appears to have been substantially altered since it was evaluated in the 2006 survey. Alterations include: resizing original window openings, the replacement of original windows, and re-cladding with an incompatible material. The property does not retain sufficient integrity to be eligible for listing in the National Register, the California Register, or for local designation.

P5b Description/Date of Photo Northwest elevation, view facing southeast/2019

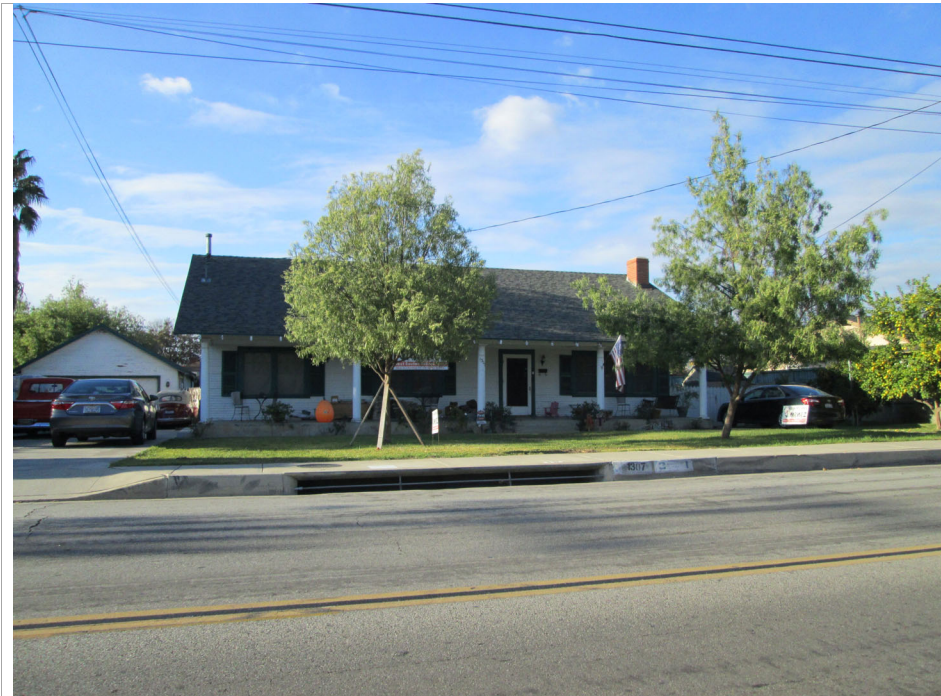
P5b Description/Date of Photo Southeast elevation, view facing northwest/2018

The property does not appear to have been substantially altered since it was evaluated in the 2006 survey. No changes are proposed to the status code assigned in 2006.

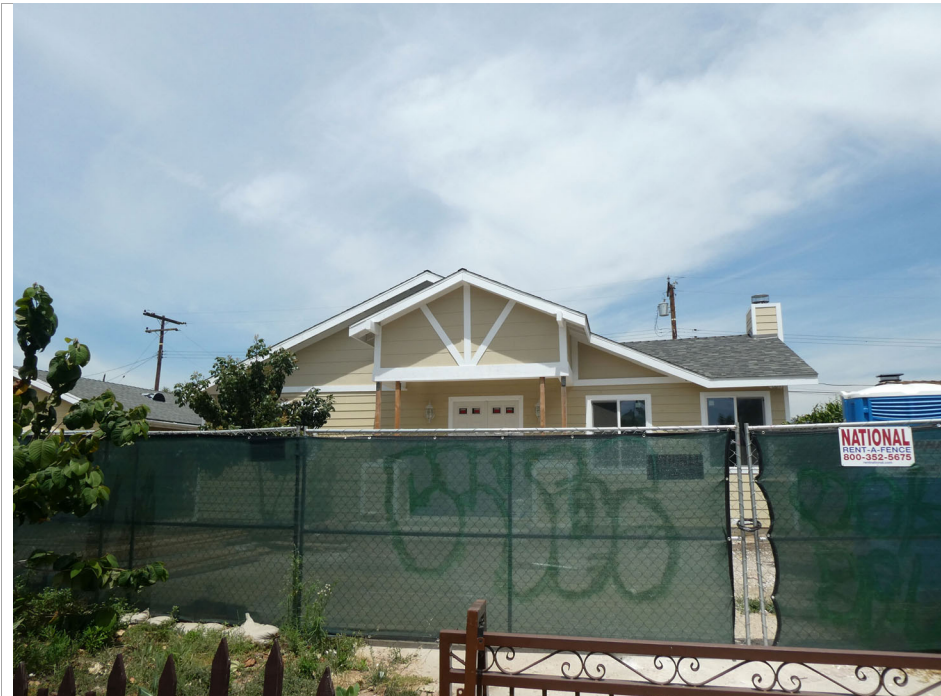
P5b Description/Date of Photo Southeast elevation, view facing northwest/2019

The residence on the property appears to have been substantially altered since it was evaluated in the 2006 survey. Alterations include: incompatible changes to front entrance, re-cladding with an incompatible material, and roofline reconfigurations. The property does not retain sufficient integrity to be eligible for listing in the National Register, the California Register, or for local designation.

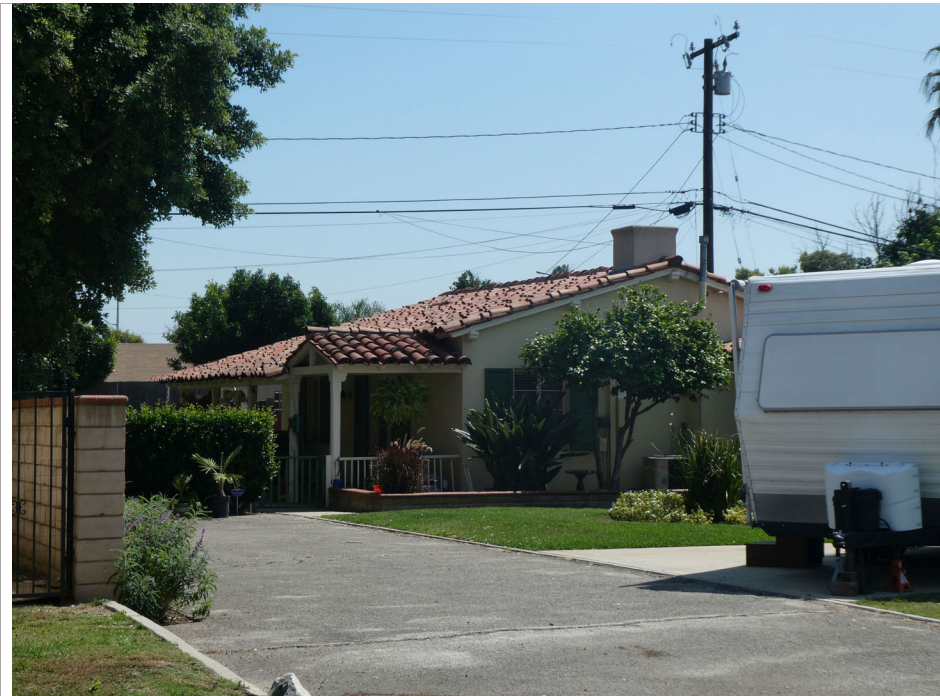
P5b Description/Date of Photo North elevation, view facing southwest/2019

The property does not appear to have been substantially altered since it was evaluated in the 2006 survey. No changes are proposed to the status code assigned in 2006.

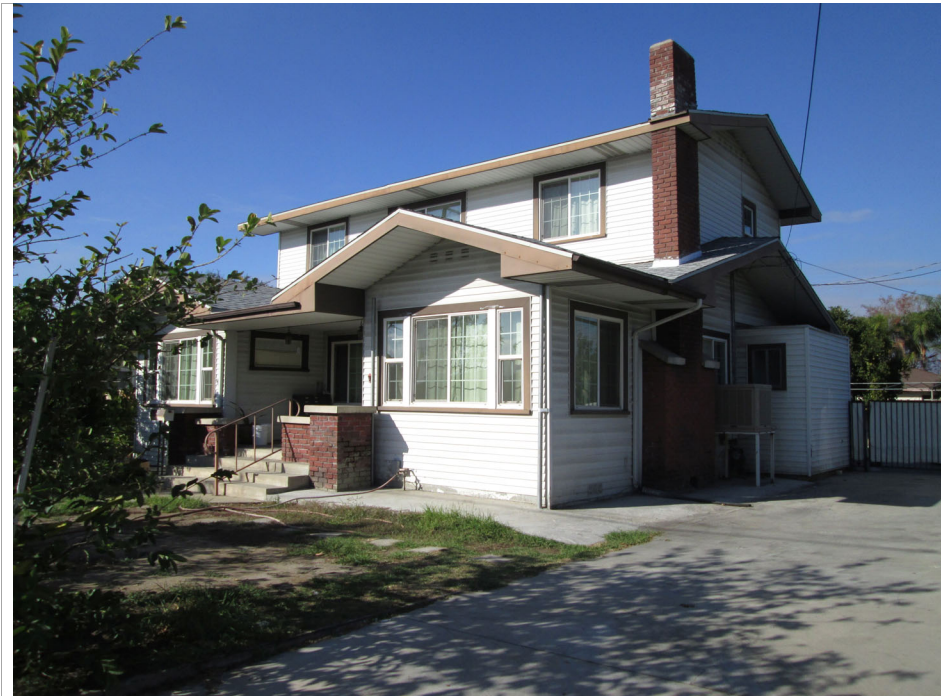
The property does not appear to have been substantially altered since it was evaluated in the 2006 survey. Original windows have been replaced with vinyl sash, but the sizing has not been altered. No changes are proposed to the status code assigned in 2006.

P5b Description/Date of Photo South elevation, view facing northwest/2018

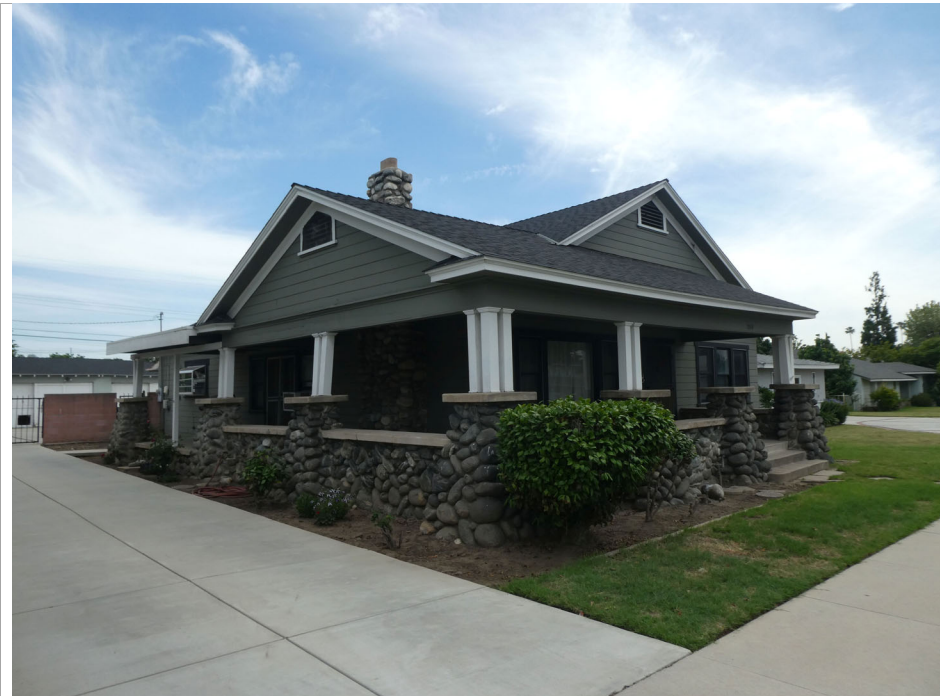
P5b Description/Date of Photo North elevation, view facing southwest/2019

The property does not appear to have been substantially altered since it was evaluated in the 2006 survey. No changes are proposed to the status code assigned in 2006.

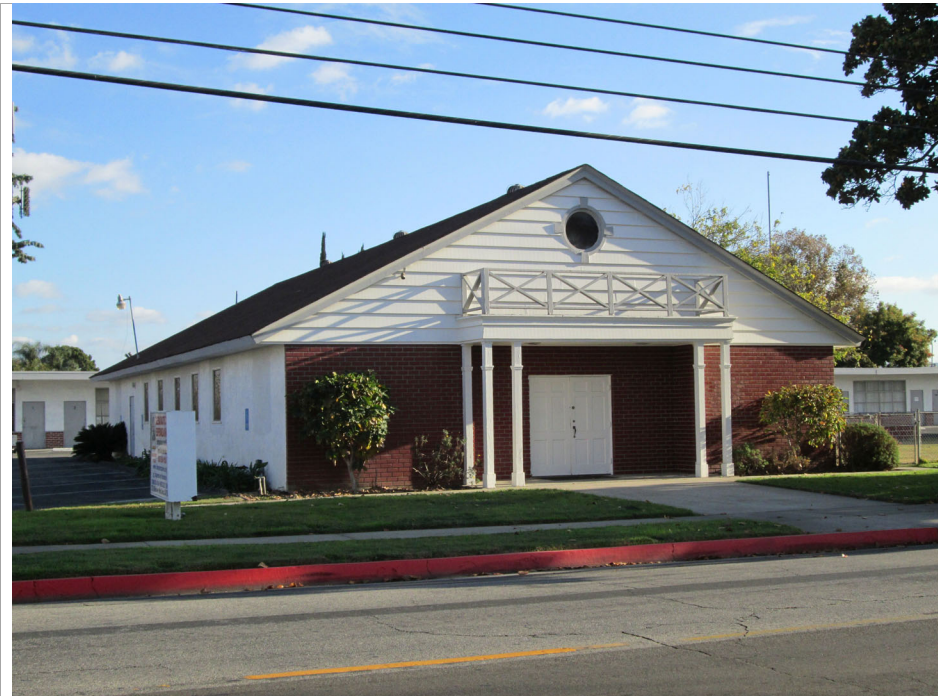
P5b Description/Date of Photo Northwest elevation, view facing south/2018

The property does not appear to have been substantially altered since it was evaluated in the 2006 survey. No changes are proposed to the status code assigned in 2006.

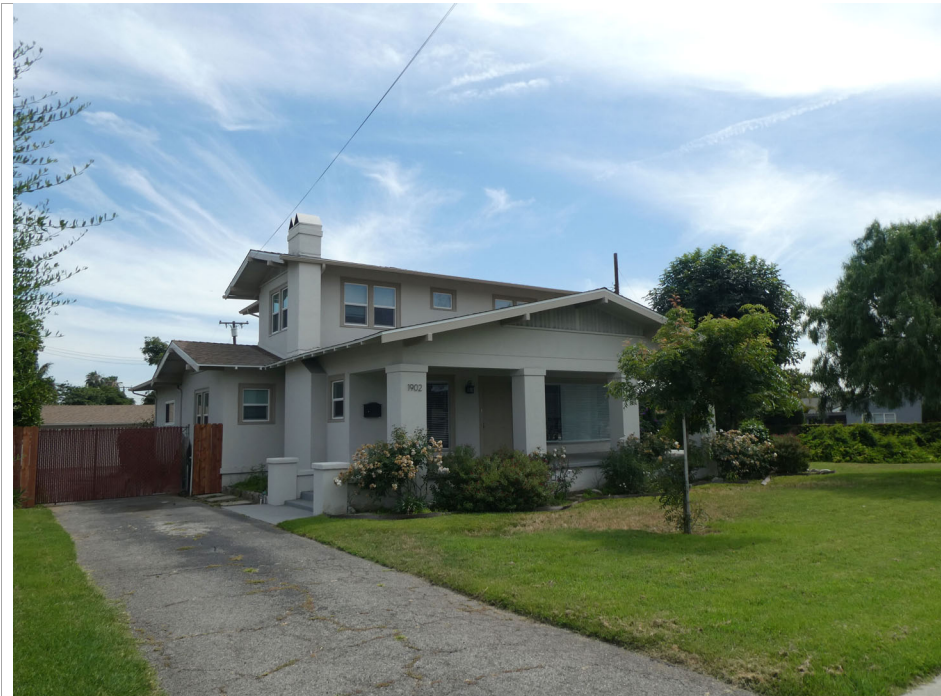
P5b Description/Date of Photo North elevation, view facing southwest/2019

The property does not appear to have been substantially altered since it was evaluated in the 2006 survey. No changes are proposed to the status code assigned in 2006.

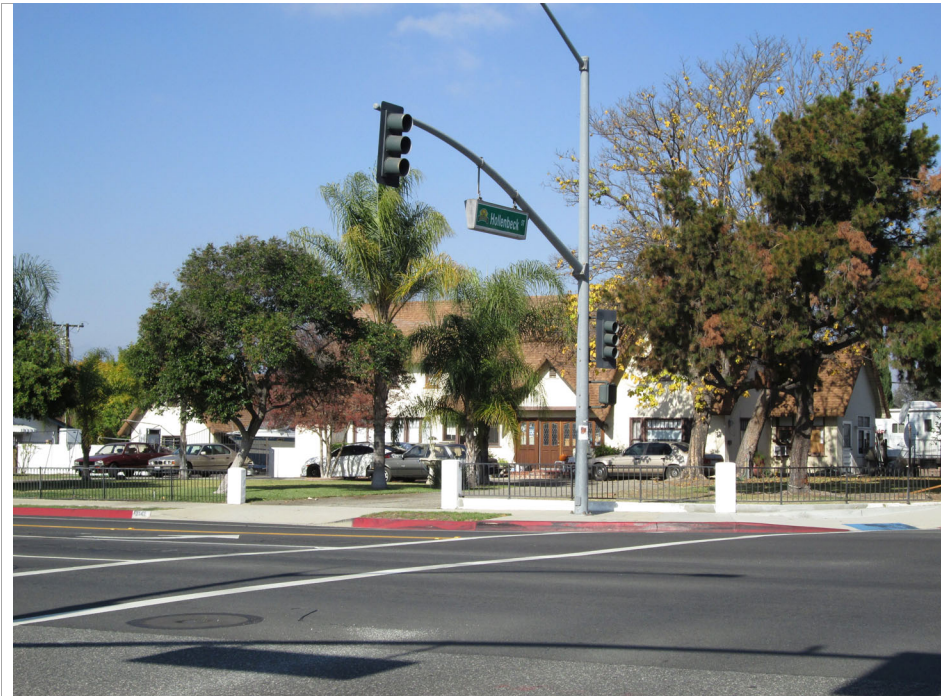
P5b Description/Date of Photo South elevation, view facing northwest/2018

The property does not appear to have been substantially altered since it was evaluated in the 2006 survey. No changes are proposed to the status code assigned in 2006.

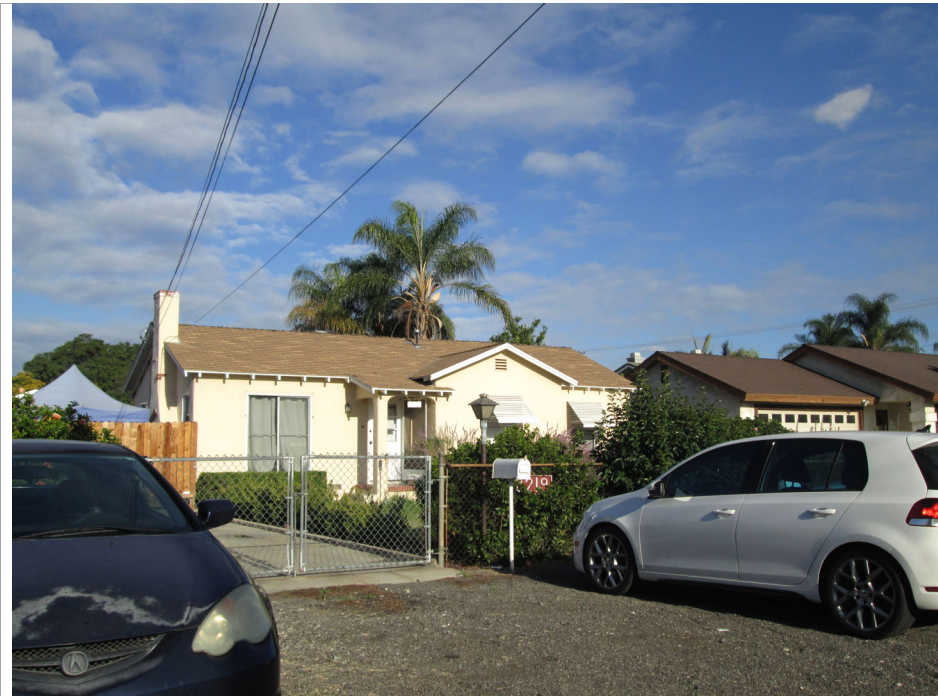
P5b Description/Date of Photo Southwest elevation, view facing east/2018

The property does not appear to have been substantially altered since it was evaluated in the 2006 survey. No changes are proposed to the status code assigned in 2006.

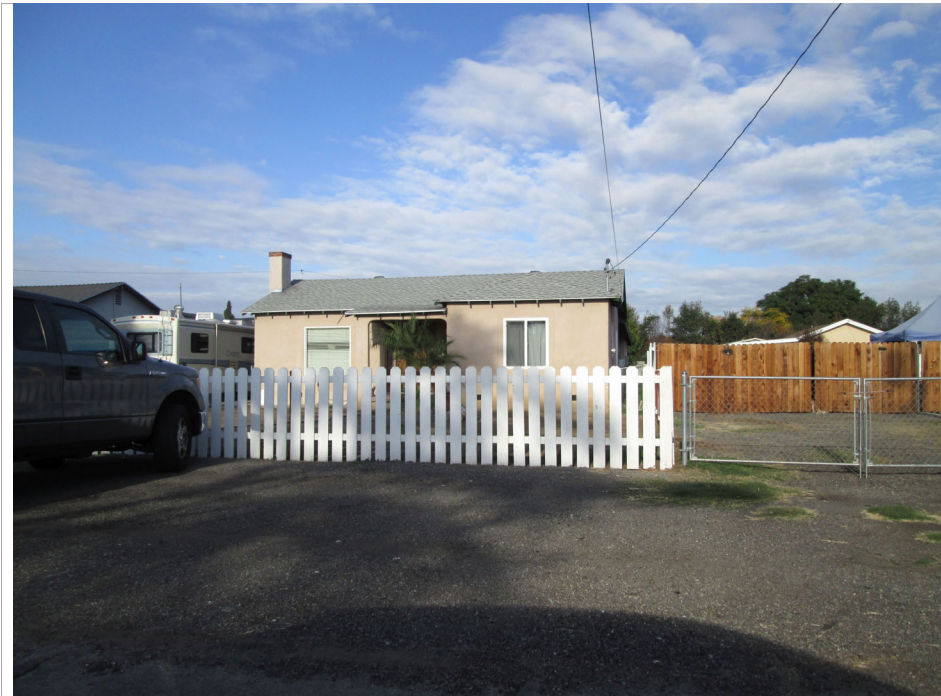
The residence on the property appears to have been substantially altered since it was evaluated in the 2006 survey. Alterations include: resizing original window openings and the replacement of original windows with vinyl sash. The property does not retain sufficient integrity to be eligible for listing in the National Register, the California Register, or for local designation.

P5b Description/Date of Photo South elevation, view facing north/2018

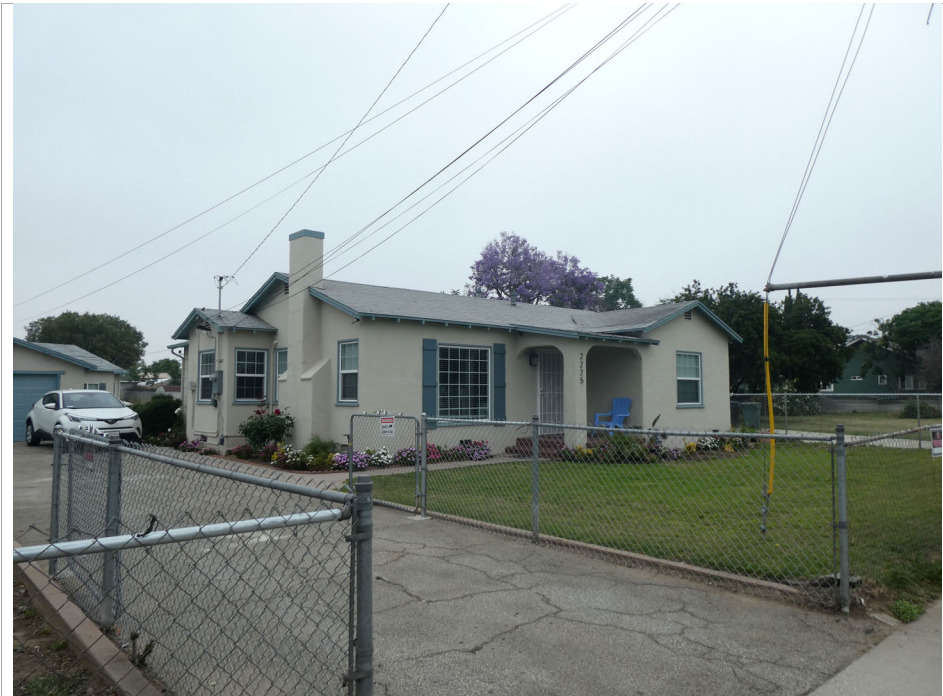
The property does not appear to have been substantially altered since it was evaluated in the 2006 survey. Original windows have been replaced with vinyl sash, but the sizing has not been altered. No changes are proposed to the status code assigned in 2006.

P5b Description/Date of Photo Southwest elevation, view facing east/2019

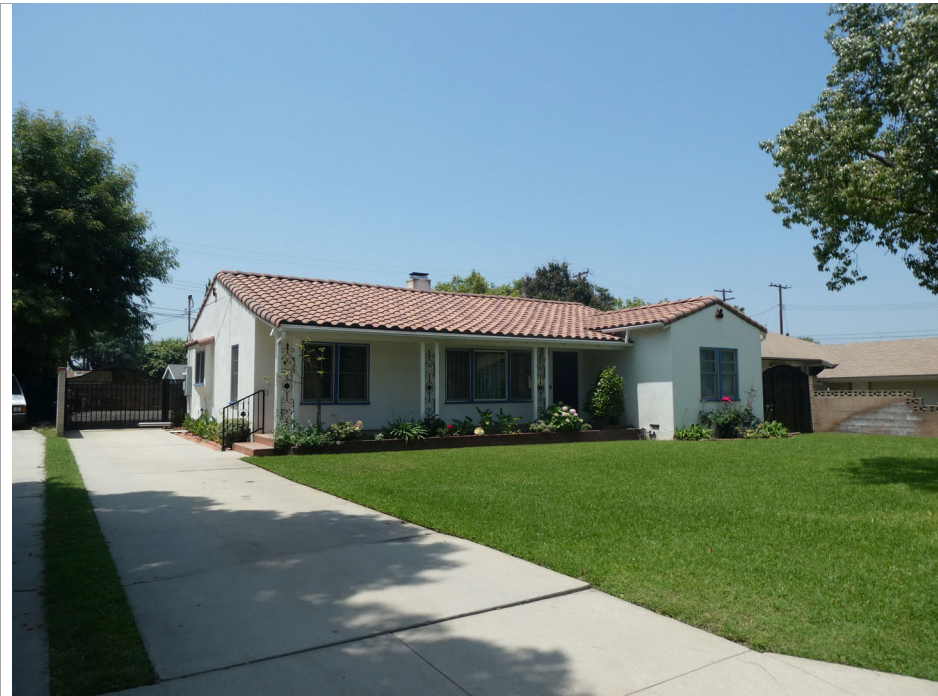
P5b Description/Date of Photo Northeast elevation, view facing west/2019

The property does not appear to have been substantially altered since it was evaluated in the 2006 survey. No changes are proposed to the status code assigned in 2006.

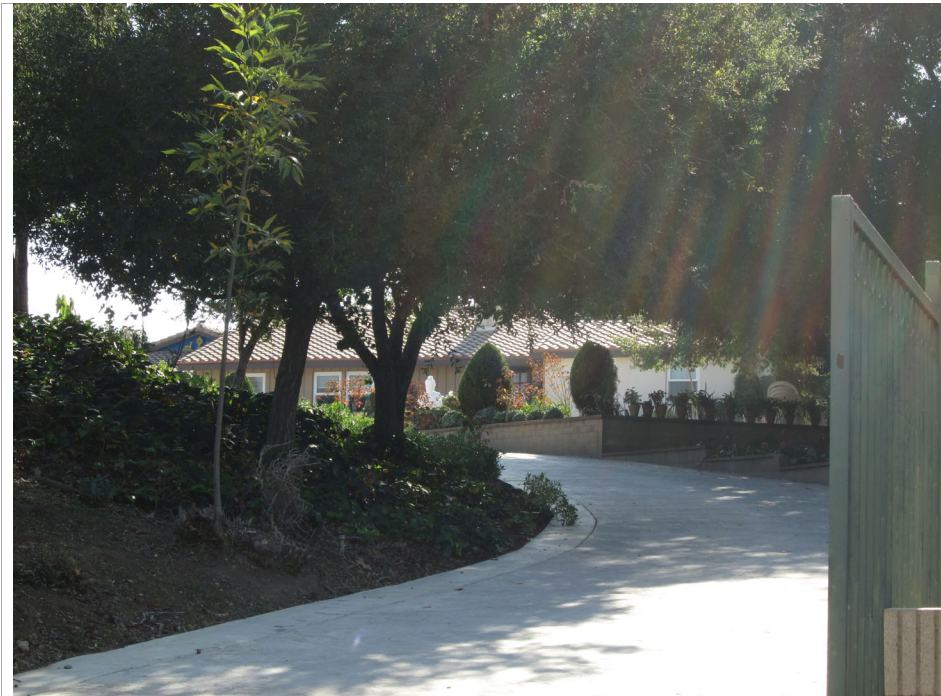
The residence on the property appears to have been substantially altered since it was evaluated in the 2006 survey. Though the property was not fully visible from the public right-of-way, alterations appear to include: resizing original window openings, the replacement of original windows, and re-cladding with an incompatible material. The property does not retain sufficient integrity to be eligible for listing in the National Register, the California Register, or for local designation.

P5b Description/Date of Photo Property not visible from public right-of-way, view facing south/2018

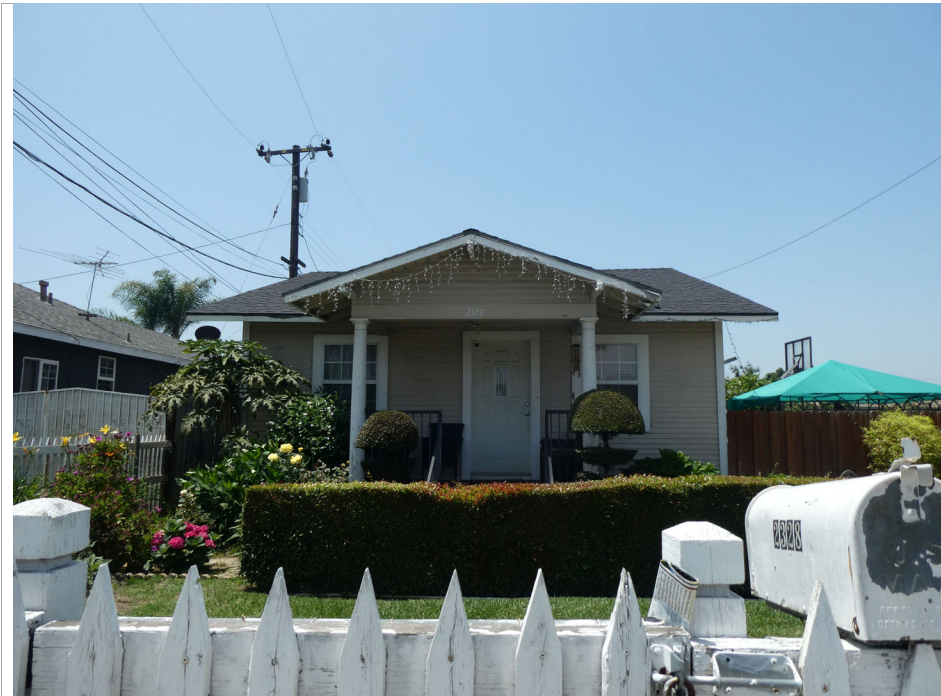
P5b Description/Date of Photo Northeast elevation, view facing southwest/2019

The property does not appear to have been substantially altered since it was evaluated in the 2006 survey. No changes are proposed to the status code assigned in 2006.

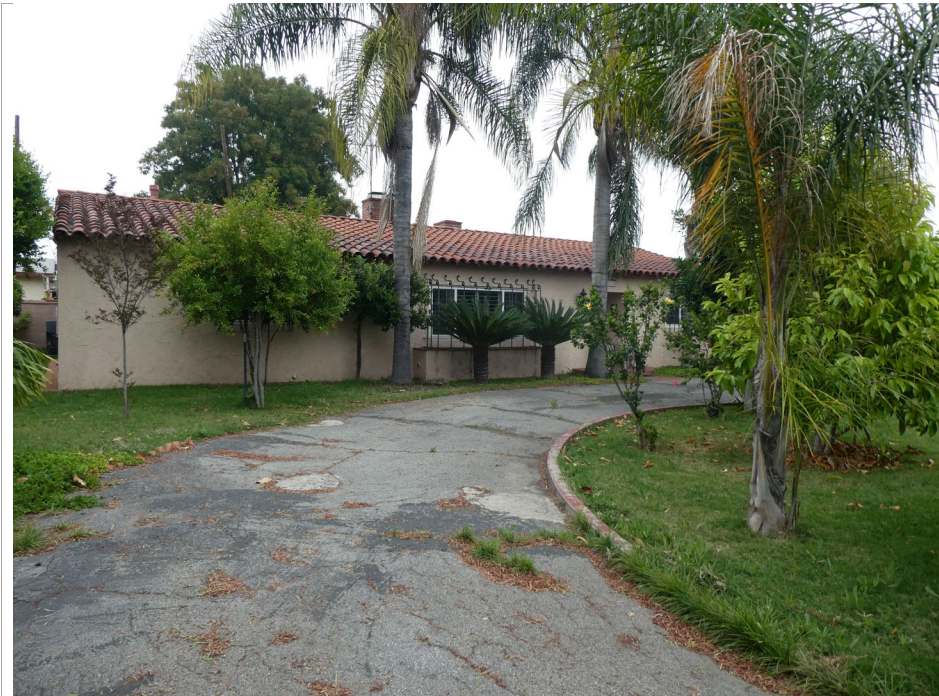
P5b Description/Date of Photo Southwest elevation, view facing east/2019

The property does not appear to have been substantially altered since it was evaluated in the 2006 survey. No changes are proposed to the status code assigned in 2006.

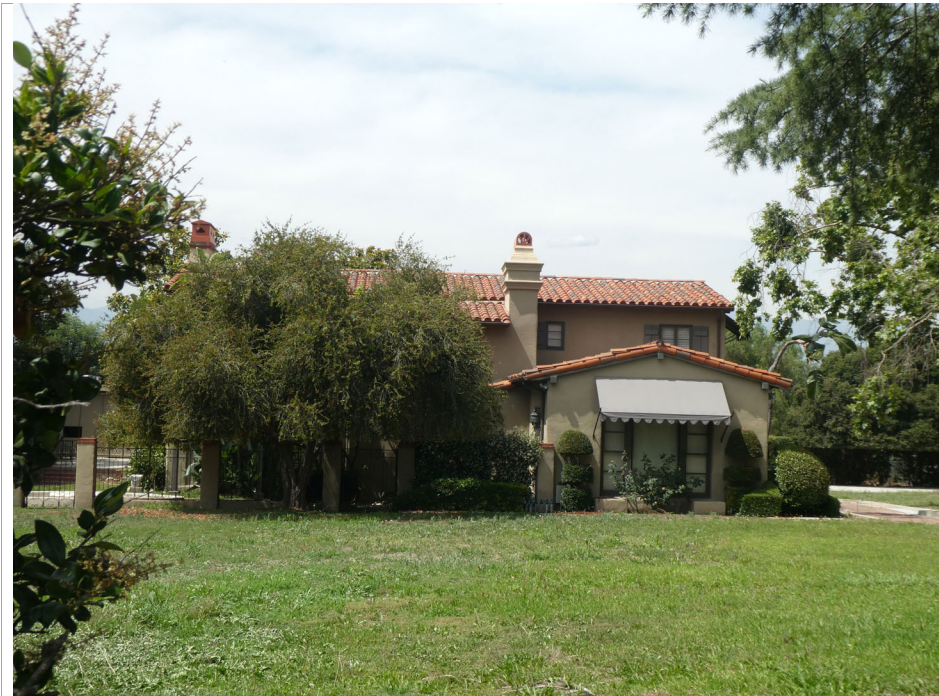
P5b Description/Date of Photo South elevation, view facing north/2018

The property does not appear to have been substantially altered since it was evaluated in the 2006 survey. No changes are proposed to the status code assigned in 2006.

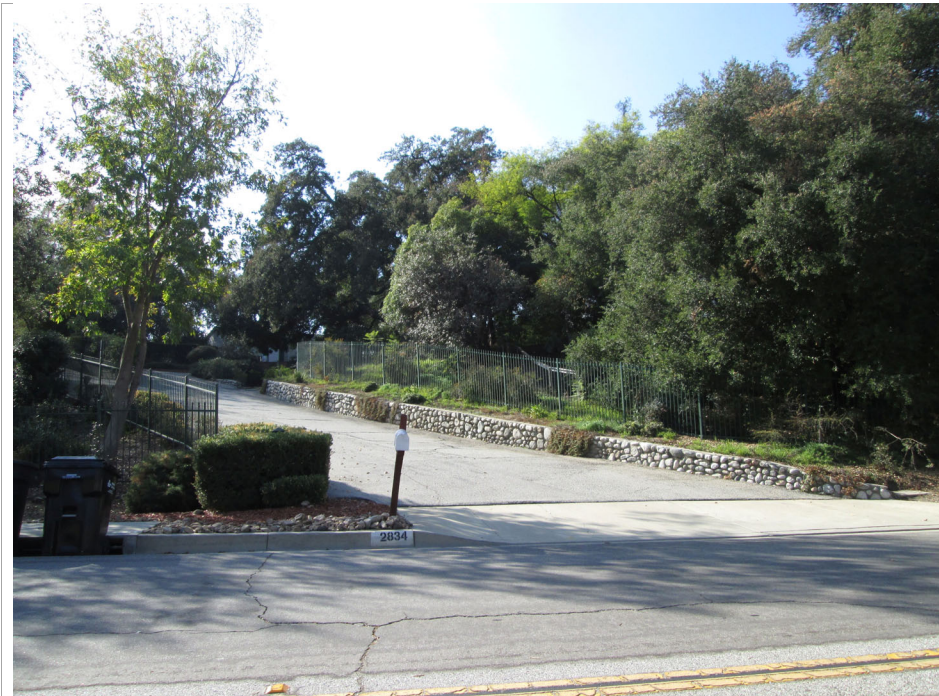
The property is not visible from the public right-of-way. Further evaluation is needed to determine if it remains eligible for listing in the National Register, the California Register, and for local designation.

P5b Description/Date of Photo Property not visible from public right-of-way, view facing southeast/2018

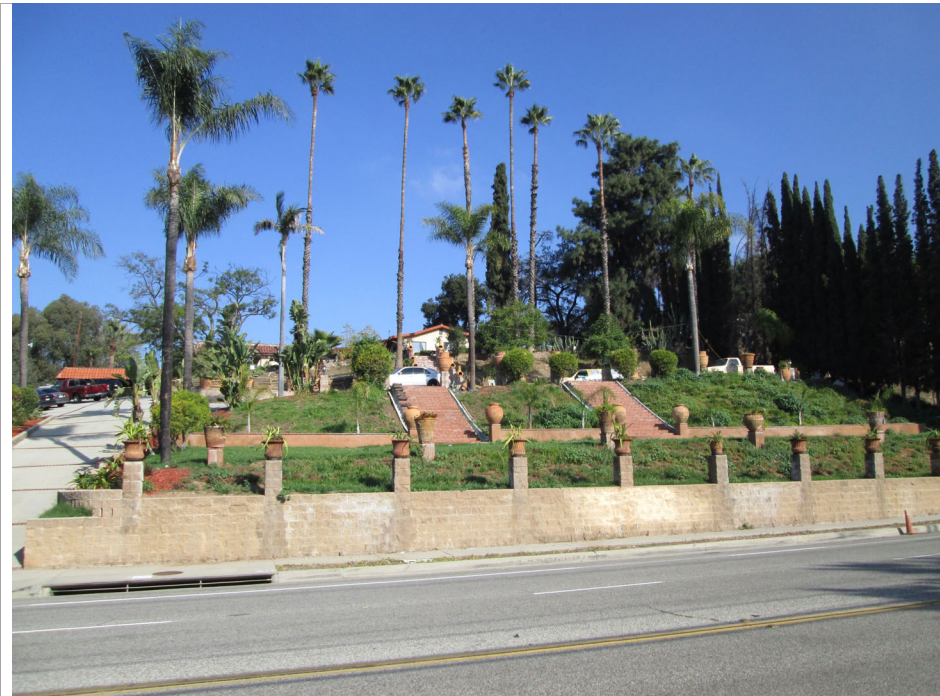
***Resource Name or #:** 3121 E. Cameron Ave.

The property is not visible from the public right-of-way. Further evaluation is needed to determine if it remains eligible for listing in the National Register, the California Register, and for local designation.

P5b Description/Date of Photo South elevation, view facing northeast/2018

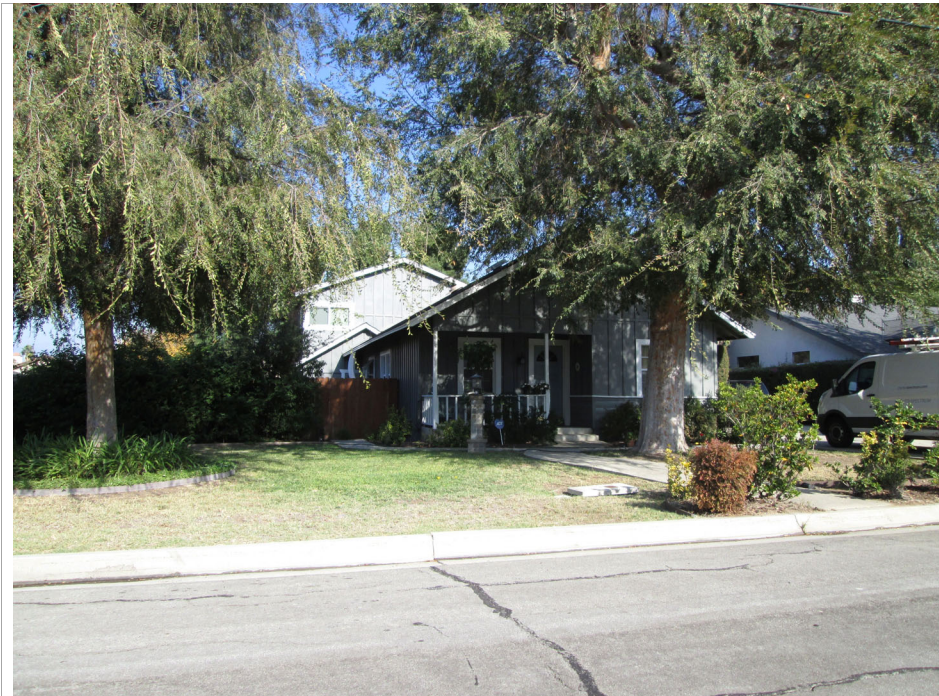
The property does not appear to have been substantially altered since it was evaluated in the 2006 survey. No changes are proposed to the status code assigned in 2006.

P5b Description/Date of Photo South elevation, view facing northeast/2018

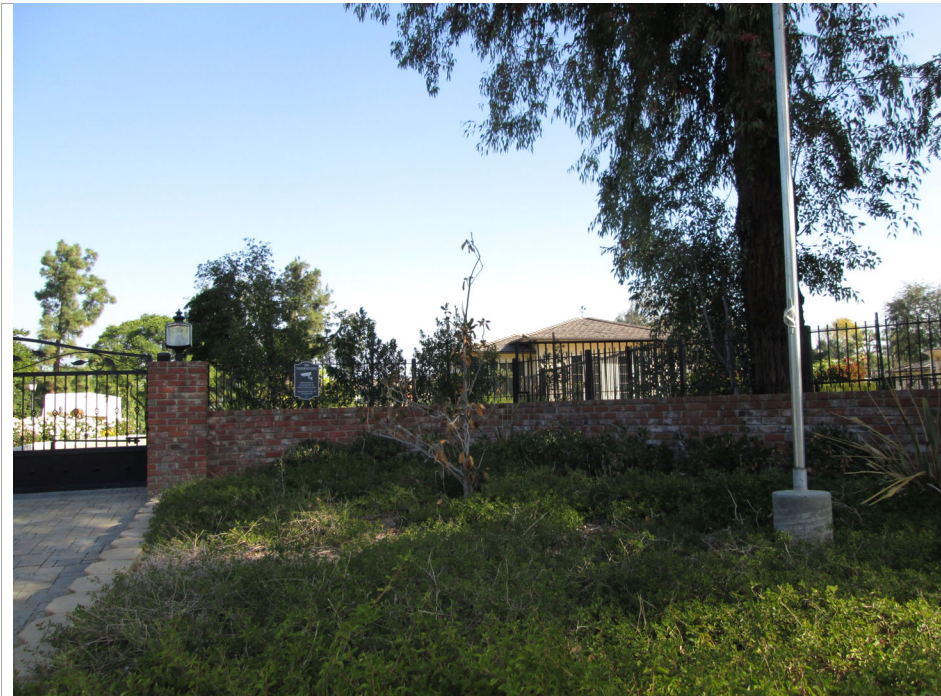
The property is not visible from the public right-of-way. Further evaluation is needed to determine if it remains eligible for listing in the National Register, the California Register, and for local designation.

P5b Description/Date of Photo Property not visible from public right-of-way, view facing north/2018

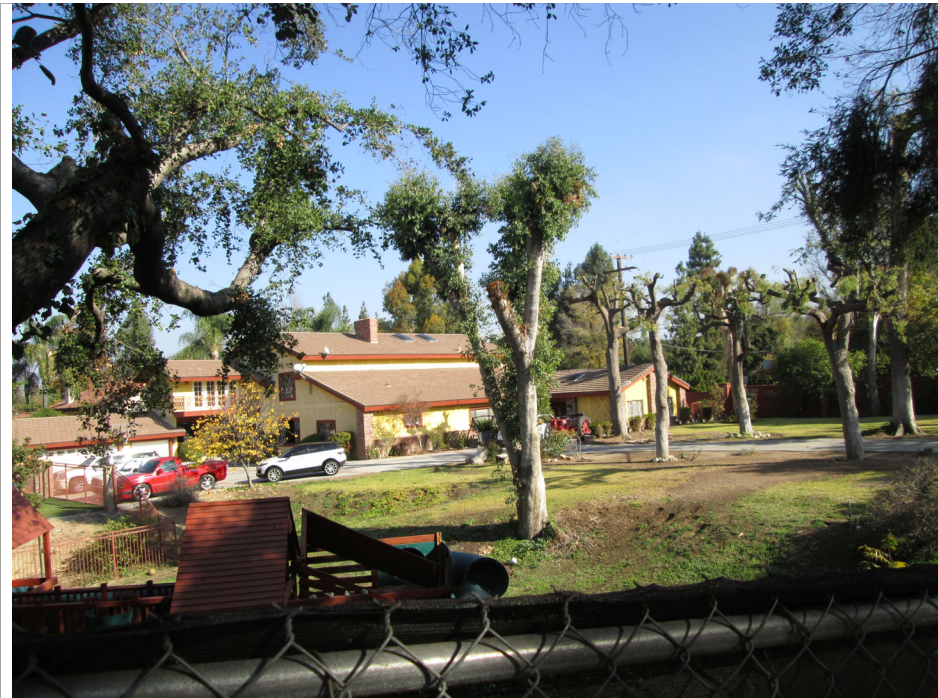
The property does not appear to have been substantially altered since it was evaluated in the 2006 survey. No changes are proposed to the status code assigned in 2006.

P5b Description/Date of Photo South elevation, view facing northeast/2018
