# Proposed Residential Development at 1024 West Workman Avenue

## Arborist Report

**September 2020**

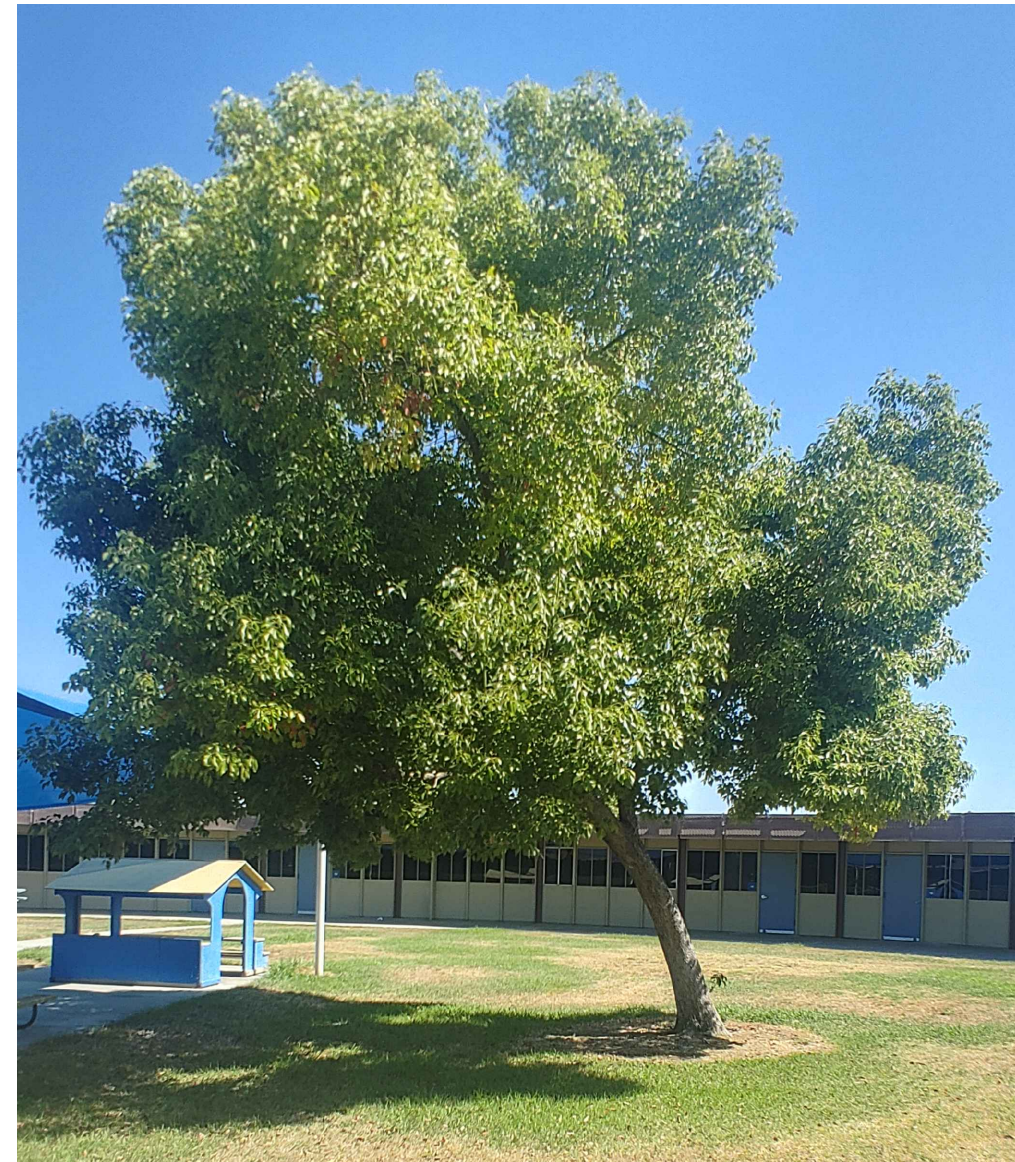
Tree # 10

T9	orange ( <i>Citrus</i> sp.)	8	10	14	NS	On-site.
T10	camphor ( <i>Cinnamomum</i> sp.)	12	25	22	NS	On-site. Leaning, potential weak trunk structure.
T11	camphor ( <i>Cinnamomum</i> sp.)	12	25	22	NS	On-site. Slightly leaning.
T12	mulberry ( <i>Morus</i> sp.)	22	35	28	NS	On-site. Poor condition and weak trunk structure, leaf loss.
T13	mulberry ( <i>Morus</i> sp.)	24	30	24	NS	On-site. Poor condition and poor crown, weak trunk structure, leaf loss.

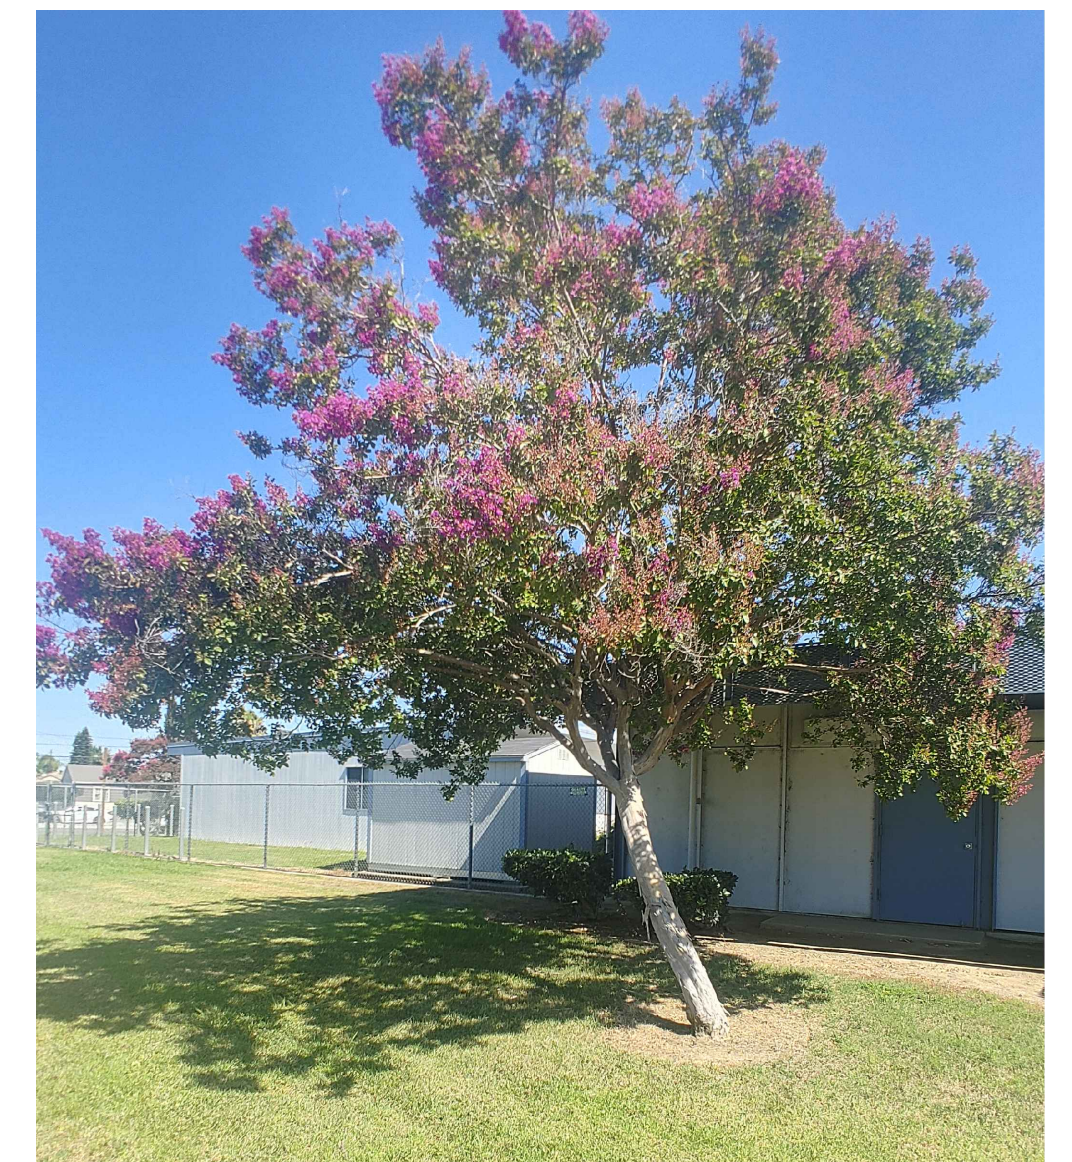
Tree # 1

Tree ID #	Common Name/ Scientific Name	DSH (inches)	Height (feet)	Canopy Spread (feet)	Significant (s) Non-Sign. (NS)	Location / Remarks
T1	crape myrtle ( <i>Lagerstroemia</i> sp.)	10	20	25	S	On-site. Leaning, potential weak trunk structure.
T2	crape myrtle ( <i>Lagerstroemia</i> sp.)	10	25	25	NS	On-site. Some trunk damage.
T3	crape myrtle ( <i>Lagerstroemia</i> sp.)	10	18	16	NS	On-site. Slightly leaning.
T4	fern pine ( <i>Podocarpus</i> sp.)	24	40	35	NS	On-site. Tree too close against existing building. Roots may be growing under foundation.
T5	crape myrtle ( <i>Lagerstroemia</i> sp.)	8	60	-	NS	On-site leaning potential weak trunk structure.
T6	crape myrtle ( <i>Lagerstroemia</i> sp.)	6	15	12	NS	On-site. Leaning with poor trunk structure.
T7	coast live oak ( <i>Quercus agrifolia</i> )	24	35+	40+	S	On-site. Roots growing up and under street sidewalk and parkway. Leaning toward street.
T8	Unidentified	30	40	25	NS	On-site. Dead.

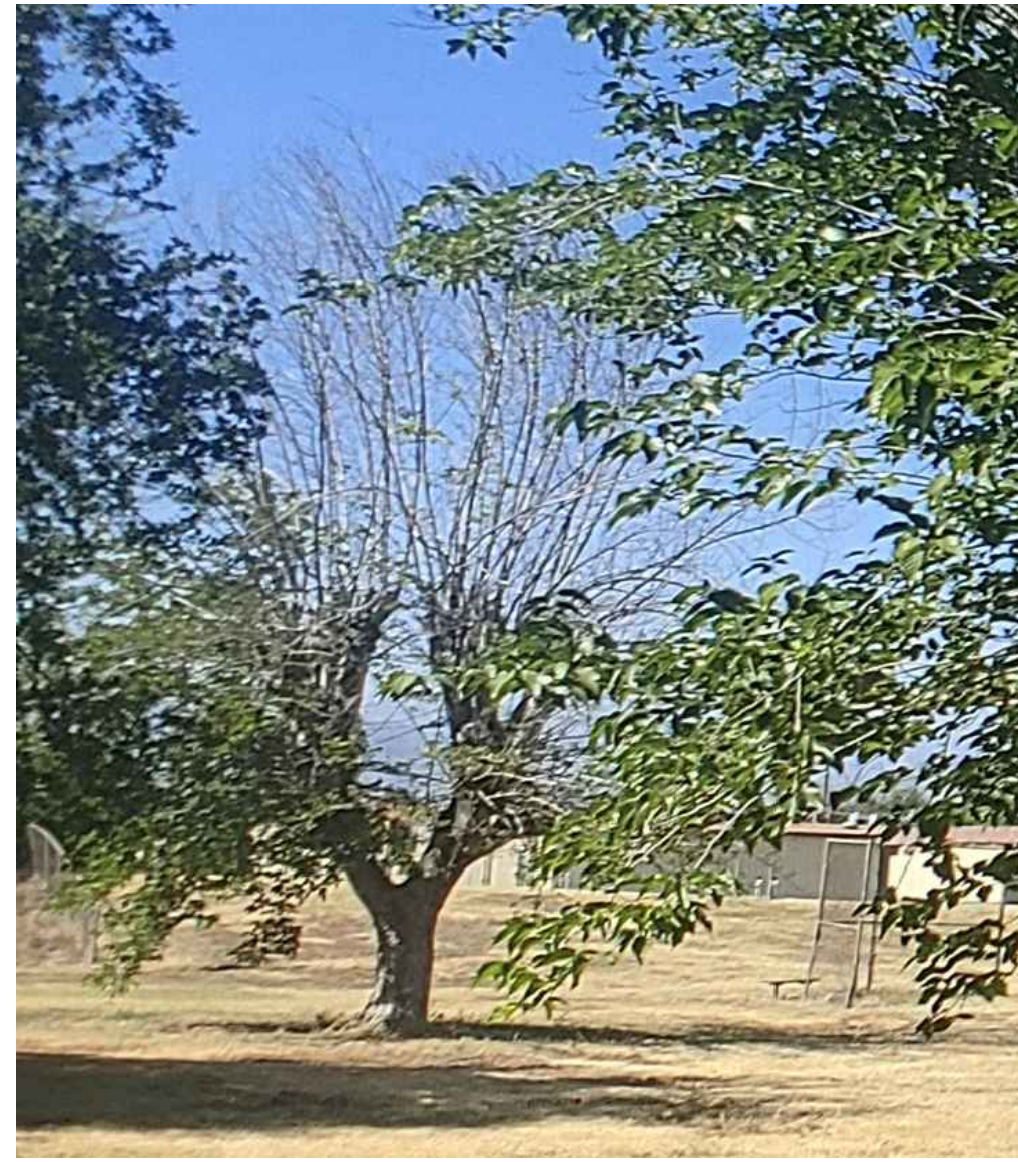
Tree # 14

Tree ID #	Common Name/ Scientific Name	DSH (inches)	Height (feet)	Canopy Spread (feet)	Significant (s) Non-Sign. (NS)	Location / Remarks
T14	mulberry ( <i>Morus</i> sp.)	26	25	25	NS	On-site. Poor condition and poor crown, open canopy, leaf loss.
T15	coast live oak ( <i>Quercus agrifolia</i> )	12	35	24	S	City Parkway. Slightly leaning, narrow parkway width, roots growing up against sidewalk.
T16	coast live oak ( <i>Quercus agrifolia</i> )	12	30	20	S	City Parkway. Open canopy, narrow parkway width, roots growing up against sidewalk.
T17	coast live oak ( <i>Quercus agrifolia</i> )	15	30	20	S	City Parkway. Narrow parkway width, roots growing up against sidewalk.
T18	coast live oak ( <i>Quercus agrifolia</i> )	8	30	30	S	On-site. Between chain link fence and cinder block wall. Fair condition, new growth evident, trunk has grown through chain link fence.
T19	coast live oak ( <i>Quercus agrifolia</i> )	7 trunks (ranging 5-8 inches)	35	35	S	On-site. Between chain link fence and cinder block wall. Good condition, new growth evident.
