PRIMARY RECORD

*Resource Name or #: 1032 E. Puente Ave.

*P10. Survey Type: (Describe) Intensive Survey of pre-1946 homes in West Covina city boundaries

BUILDING, STRUCTURE, AND OBJECT RECORD

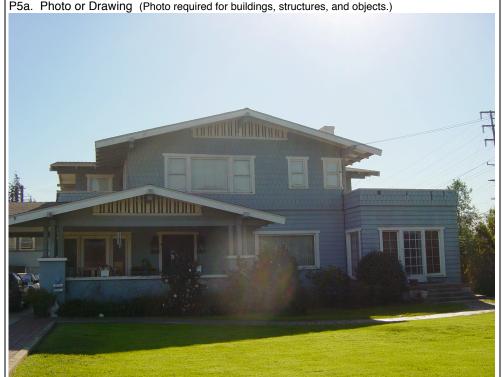
(View South, taken Nov. 22, 2005)

The house located at 1032 East Puente Avenue is a two story Craftsman style house built in 1912. The house was built by the Miller Family who bought 10 acres of land from another early West Covina Family – The Woodworths. The Millers chose to design the house in the fashion of Greene and Greene Craftsman style houses that were popular at the time. The house has a cross gabled roof with multiple roof planes. The roof has extended eaves with exposed rafter tails and decorative beams. The eaves are not boxed. There is decorative cut work vents located beneath the peaks of the front façade. The roof is finished in asphalt tile and the exterior walls are finished in wood shingle on the second floor and wood siding on the first. There is a partial width gabled front porch with columned roof supports. The front porch columns are half width and made of wood set on square piers. There is also a small porch located on the second floor. The house sits behind a grassy front lawn and several walkways surround the house. The house fronts north on Puente Avenue as is listed with the Los Angeles County Assessors Office as being a 7 bedroom, 5 bath house with 1,590 interior square feet and is situated on a 22,342 square foot lot.

1032 East Puente was constructed in 1912, according to Fidelity National Title. The building does not appear to have had any major exterior alterations, however according to City of West Covina, pre-1947 building permits are no longer available. There are reports of fire damage to the garage (repaired in 1956) and a pool was added to the rear of the property in 1964.

1032 East Puente Avenue is locally significant under National Register Criteria C: Design/Construction. The house embodies the distinctive characteristics of the Craftsman style, popular in the first part of the 20° century in West Covina. The house features key Craftsman style elements, such as wide-overhanging eaves and a large front porch with wood supports set on piers. The house is clad in both wood shingle and wood siding. The house is eligible for the California Register under the same criteria (California Register Criteria 3).
