State of California — The Resources Agency
 DEPARTMENT OF PARKS AND RECREATION
PRIMARY RECORD

Page 1 of 2 *Resource Name or #: 1940 E. Cortez Ave.

*P10. Survey Type: (Describe)
 Intensive Survey of pre-1946 homes in West Covina city boundaries

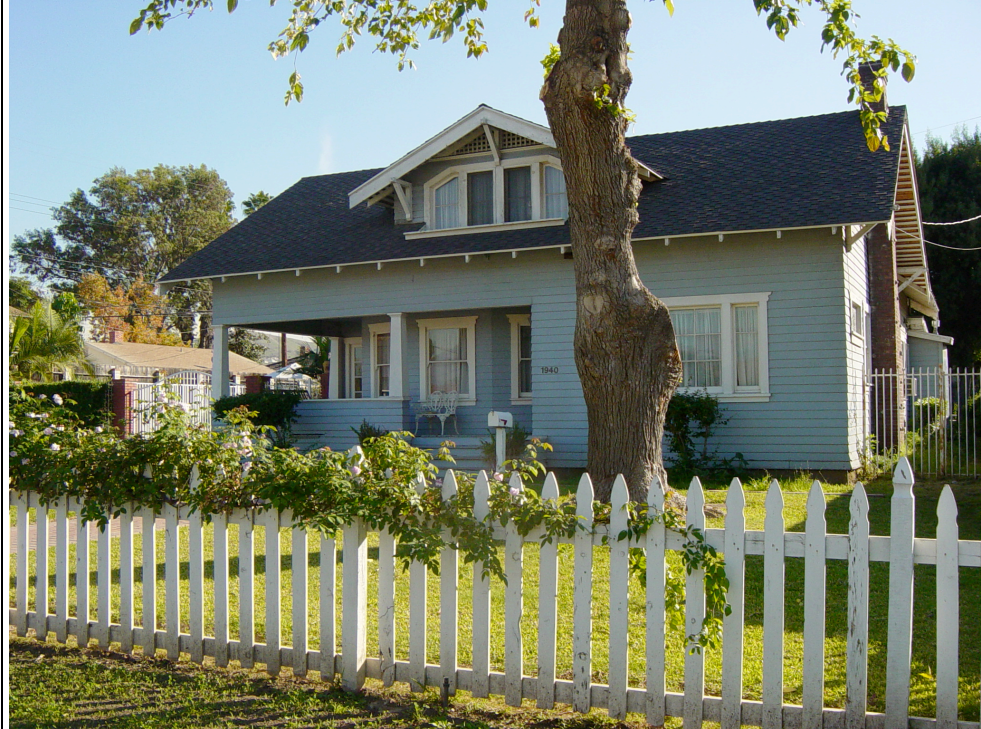
P5a. Photo or Drawing (Photo required for buildings, structures, and objects.)

The house located at 1940 E. Cortez Avenue is a one-and-a-half story Craftsman bungalow built in 1911. The house is a modified square shape with a side-facing gable and corner porch incorporated into the plan. The front façade is characterized by a front-facing gabled dormer, exposed rafters and triangular knee braces. The roof is finished in asphalt shingle and the walls are finished with wood siding. The chimney is constructed of brick. The front porch is incorporated into the façade and occupies the corner of the house, wrapping around the side. The porch has railings constructed of wood siding that matches the walls and simple wood piers as supports. The house is set behind a small front lawn and white picket fence with one mature tree in front.

The house fronts Cortez Avenue in a quiet residential neighborhood. The property is listed with the County of Los Angeles as being a 4 bedroom, 1 bath single-family residence with 1,988 square feet of interior space and a lot size of 19,600 square feet. The house appears to have had little exterior alteration and is in good condition.

P5b. Description of Photo:
 (View South, taken Nov. 22, 2005)
